Asset Management Committee

Agenda 25.07.2022

Structure Name: Llangollen Chainbridge

Report Ref: R1052-01 Issue No 01

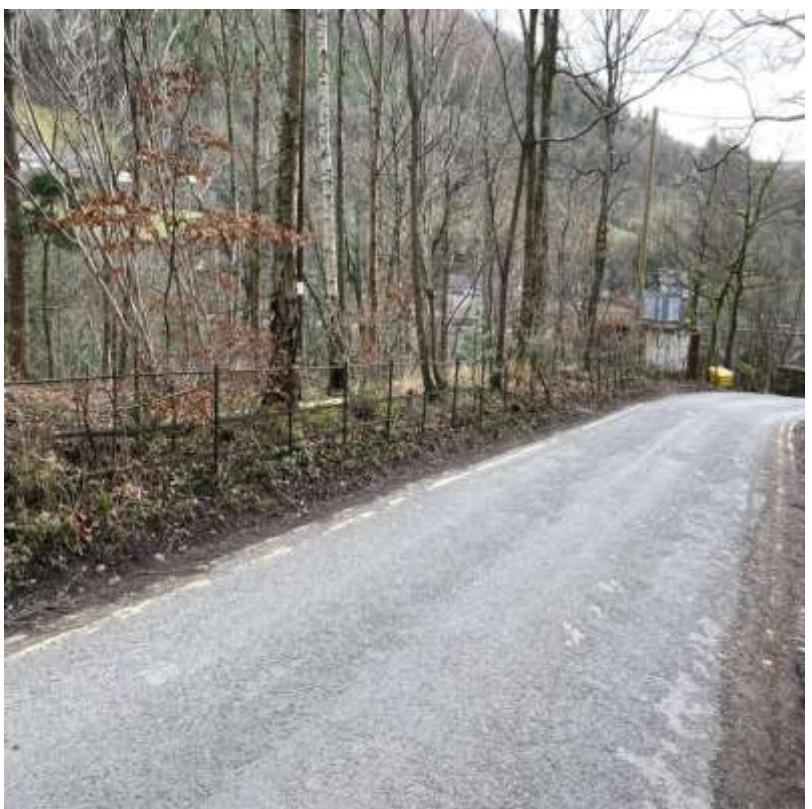
The metallic pedestrian safety fence present at the top of the North embankment is in poor condition with several rails missing and vertical members displaced presumably from vehicular impact, see photo 16.

Photo 16: North embankment. Damaged fence to top of embankment.

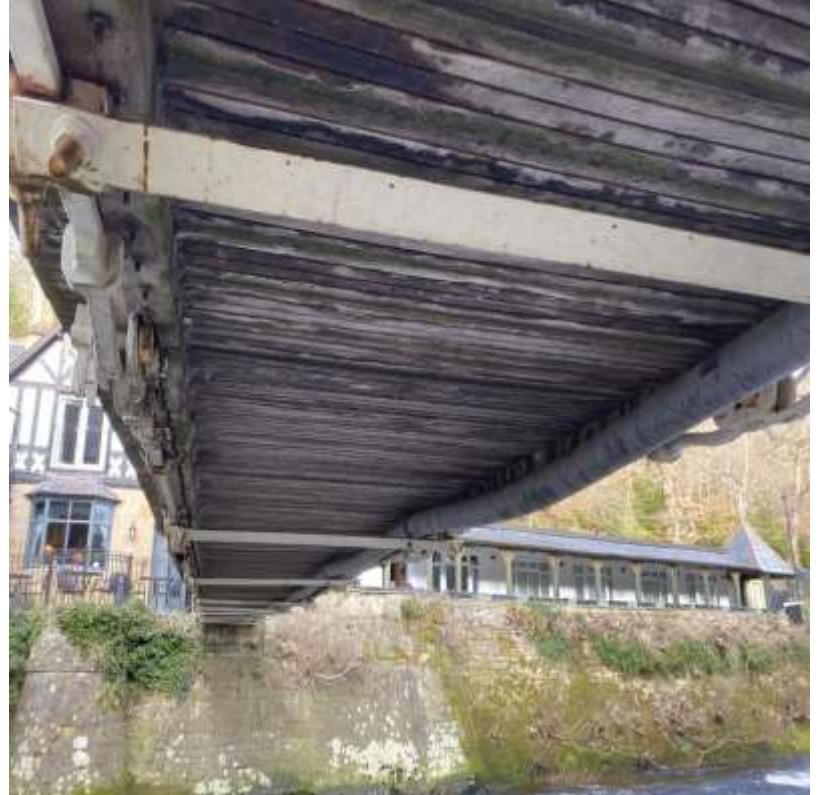
The deck chains are in good to fair condition overall only exhibiting localised areas of minor surface corrosion where the protective paint system has failed, see photo 17. The main defect noted to the deck chain is the deflection of the East chain at Ch14m, see photos 64 and 65, where the deck chain has deflected circa 40mm vertically. One of the East deck plates has deformed vertically by 12mm, photo 60.

Photo 17: Deck chains. Typical corrosion sores to deck chain links.

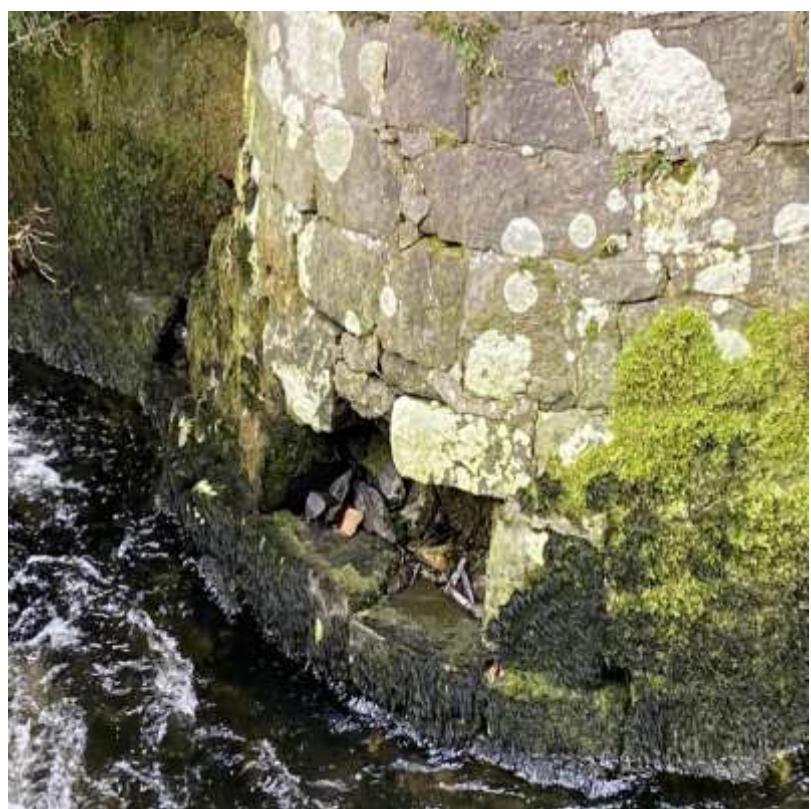
3 No. masonry blockwork units are missing from the North abutment's West turreted approach wall, see photo 18.

Photo 18: North abutment - 3No. missing masonry units to base of turreted wall on the West abutment approach.

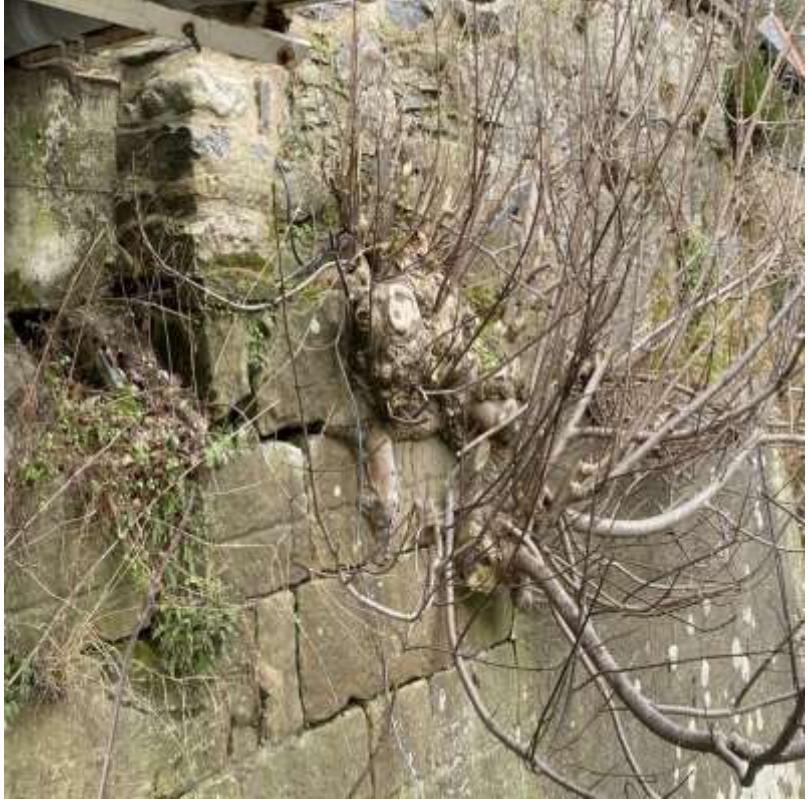
Photo 19: North abutment: Mature sapling growth to Northeast.

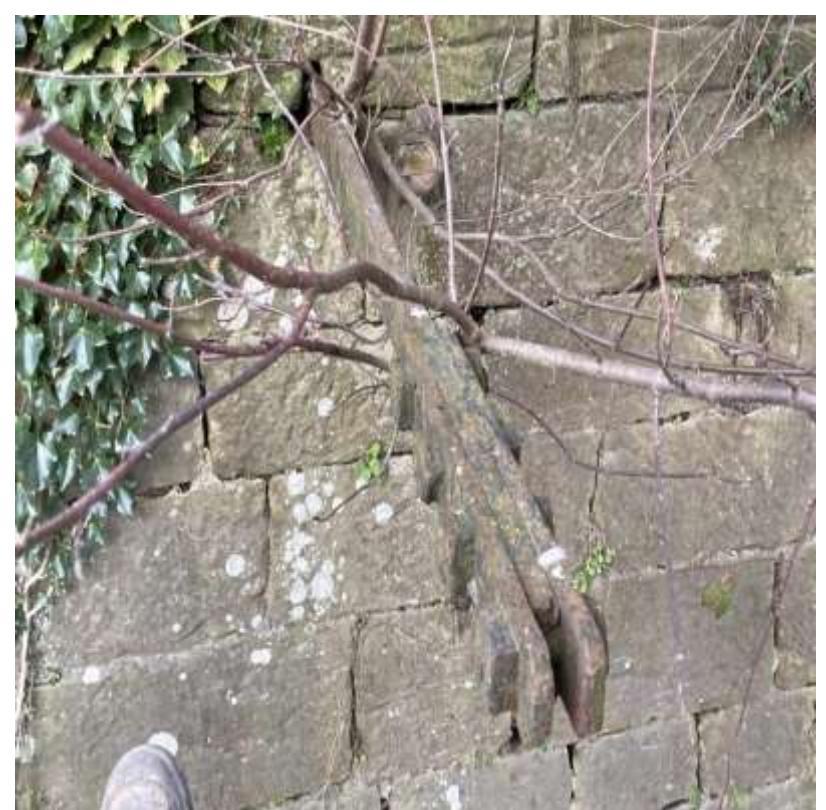
Photo 21: North abutment: Redundant metallic bracket protruding out by 1.227m.

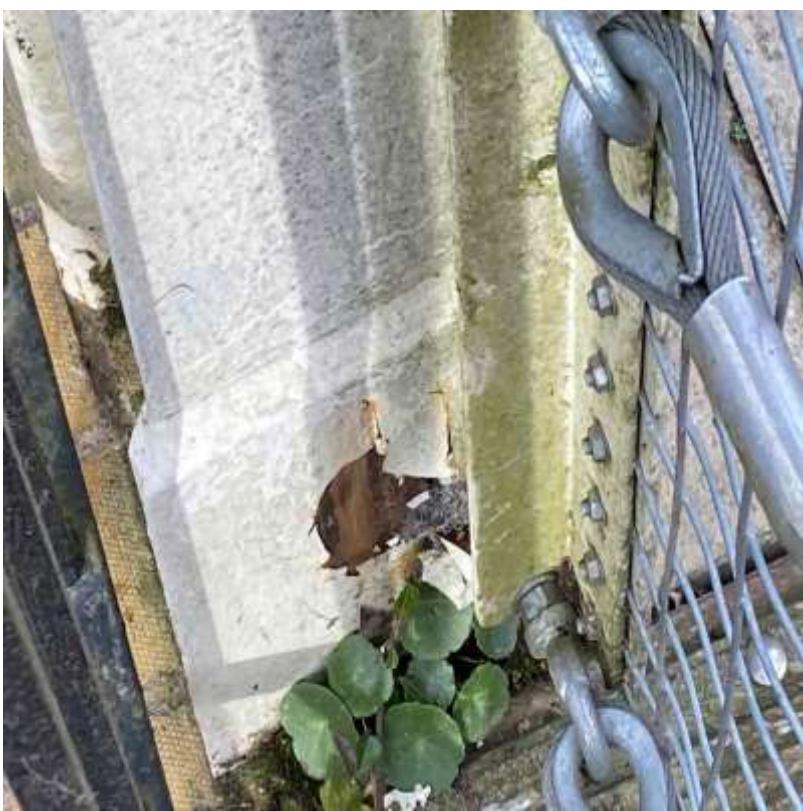
The North pylon is in fair condition with no major defects present. There is a small area (120mm \times 100mm) of surface corrosion present at the base of the Northwest stanchion, see photo 22.

Photo 22: North Pylon - Surface corrosion to Northwest stanchion at base 120mmx100mm.

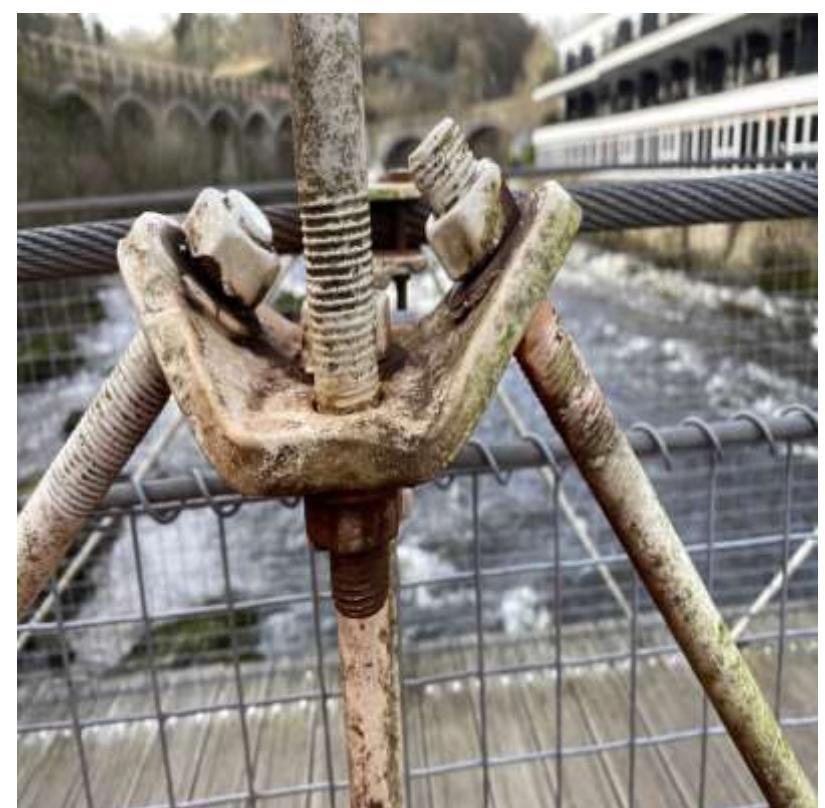
The catenary chain hangers are generally in fair condition with most protective paintwork intact. The threaded ends of the chain hangers are not protected by paint and consequently covered in light surface corrosion, see photo 23. Minimal thread protrusion beyond nut (3mm), photo 23.

Photo 23: Catenery Chain Hangers - Typical hanger with surface corrosion and minimal thread beyond nut (3mm).

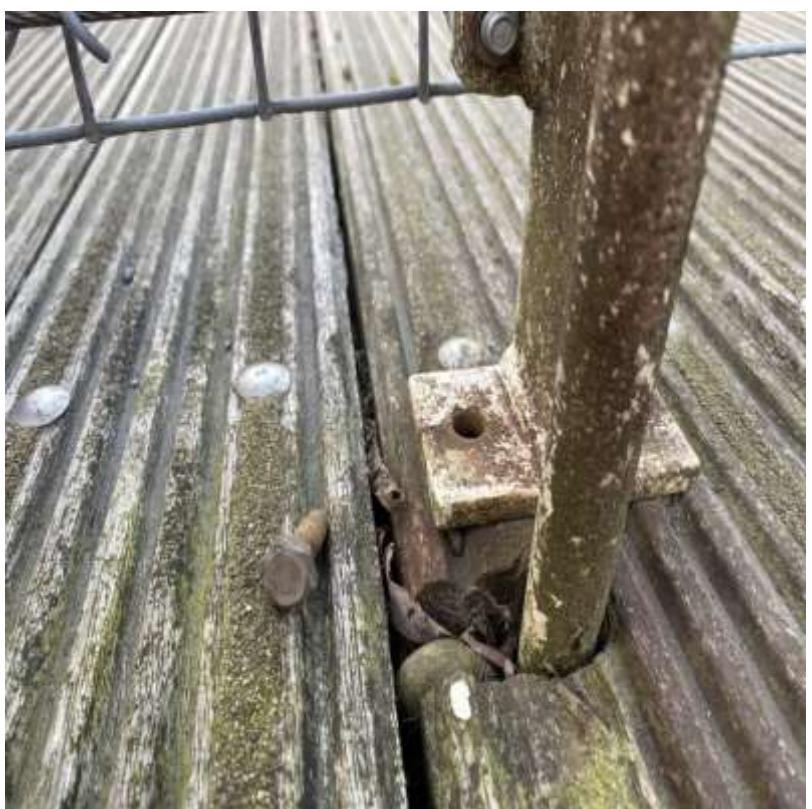
There are several missing/loose bolts to the connections with the timber decking, photos 24 and 27.

Photo 24: Parapet Central Span: East parapet upstand. Missing fixing at Ch2.3m.

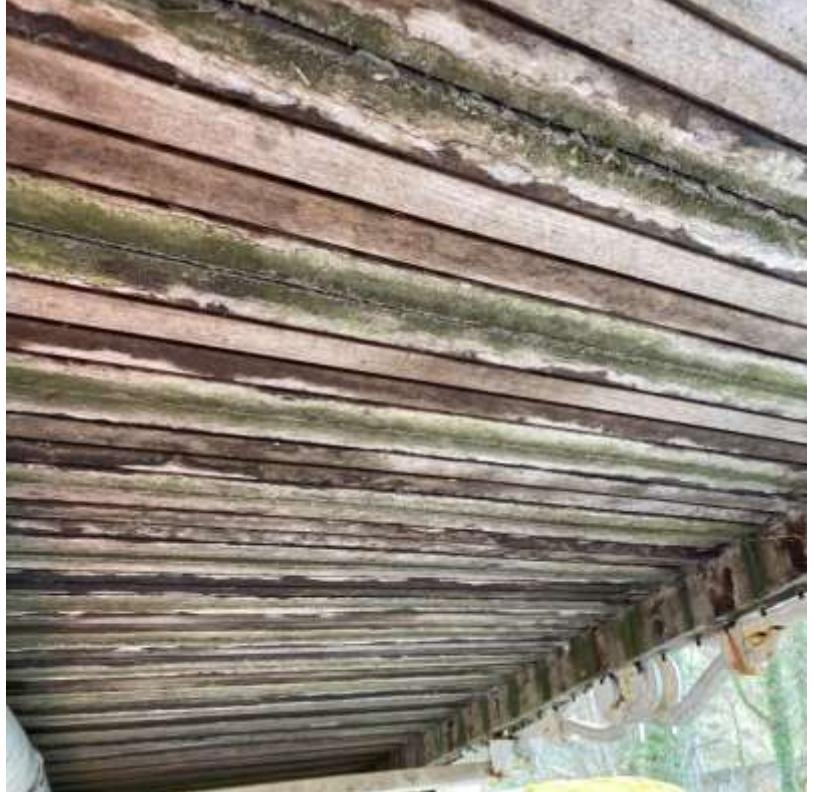
Damp staining and algae growth noted to decking soffit, photo 25.

Photo 25: Deck soffit: Typical damp staining and algae growth.

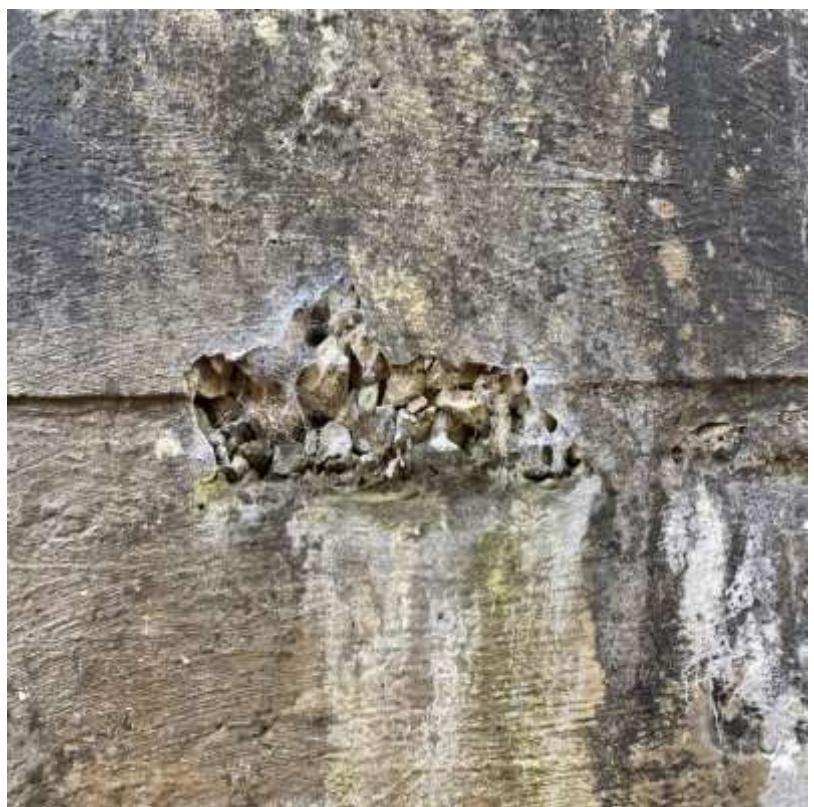
Photo 26: North face of pier: Deep honeycombing 1.7m above ground level and 3m from East edge of cut water.

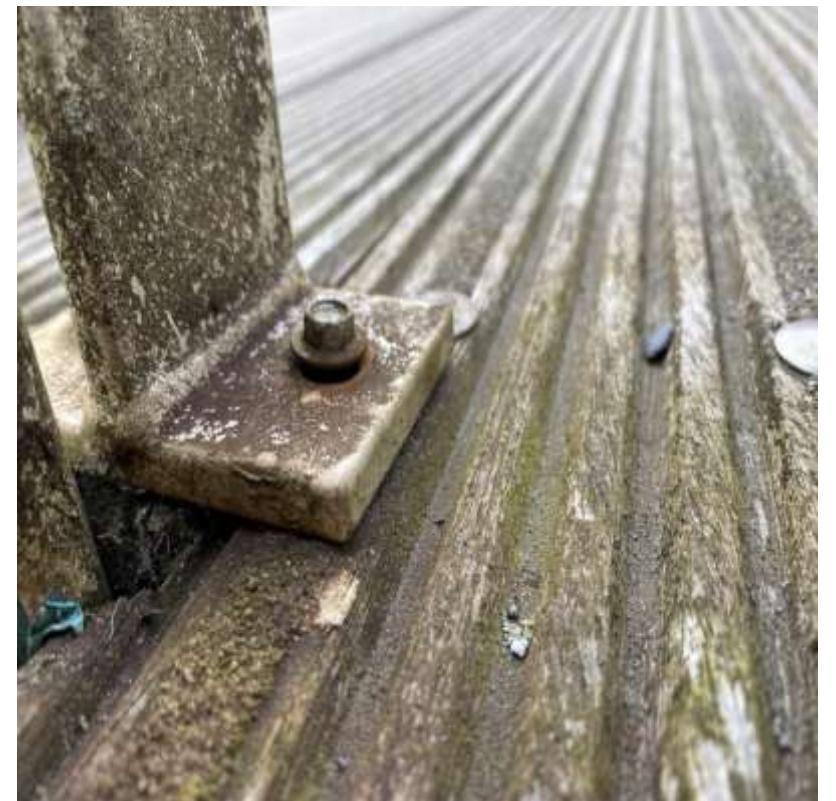
Photo 27: Loose parapet upstand fixings to the dry span Ch7.2 (West) Ch5.0 (East) and River span Ch2.1, 6.8, Ch14.1 (West)

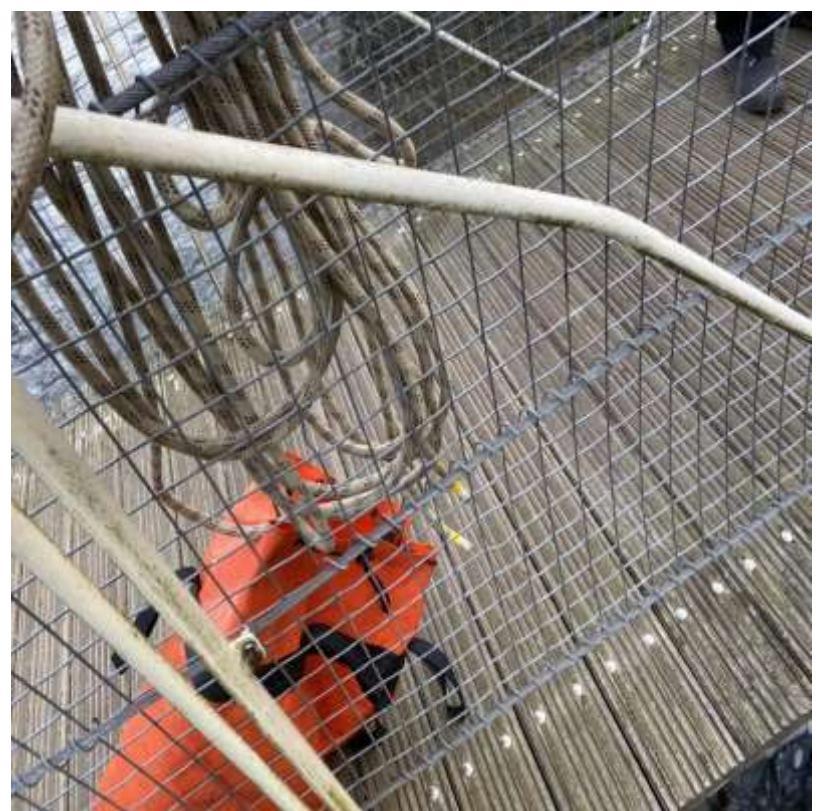
Catenary chain hanger to West side at 4.08m South of the pier has suffered impact damage to tie bar adjacent to parapet and has deflected by 20mm and rotated, photos 28 and 29.

Photo 28: Catenary chain hangers: West side at 4.08m South of pier. Impact damage to West tie bar adjacent to parapet deflected by 20mm.

- The displacement of the East deck chain identified at Ch14m (see section 3.3) is likely to have occurred during a flood event, similarly the bent catenary chain hanger present to the West side at 4.08m South of the pier has also suffered from impact damage, presumably from a similar event. It is recommended that these items are repaired to restore the load capacity and prevent further deterioration.

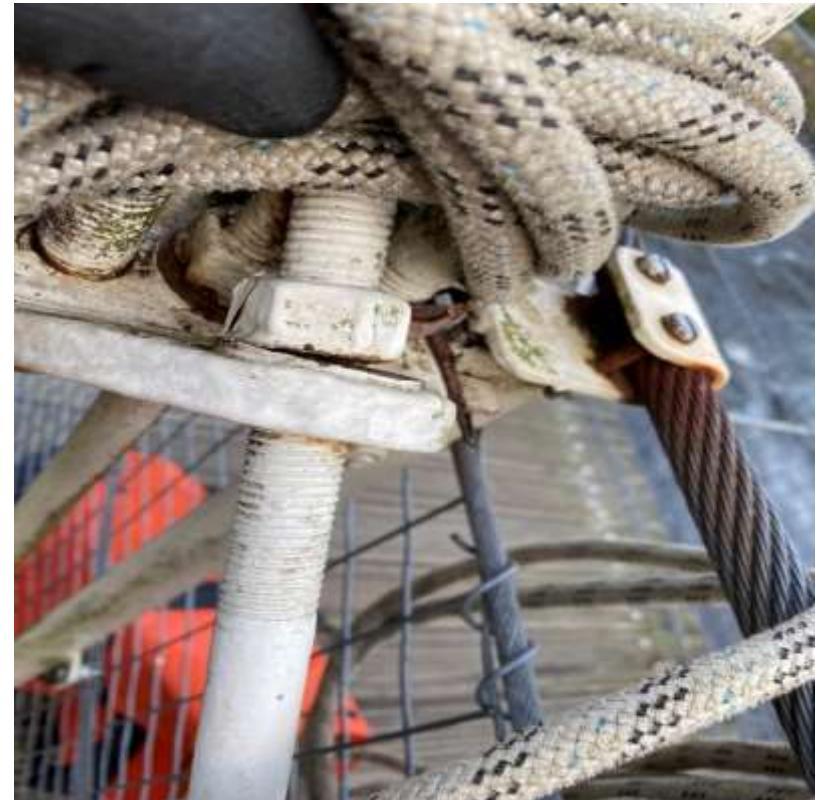
Photo 29: Catenary chain hangers: West side at 4.08m South of pier. Rotated tie bar due to impact.

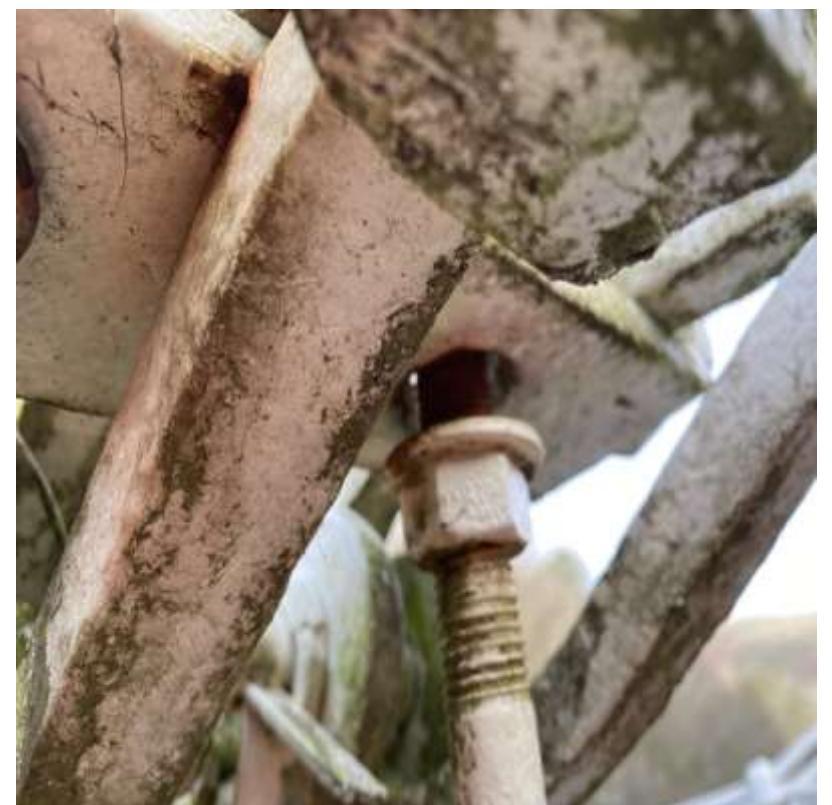
Localised surface corrosion is generally present to vertical hanger anchors and at Ch4.08m the hanger has de-threaded and is not set correctly, the thread protrusion of this hanger anchor is 0mm, see photos 30 and 31.

Photo 31: Catenary chain hangers: Stripped thread at 4.08m South of pier. 15mm gap between lower nut and bracket.

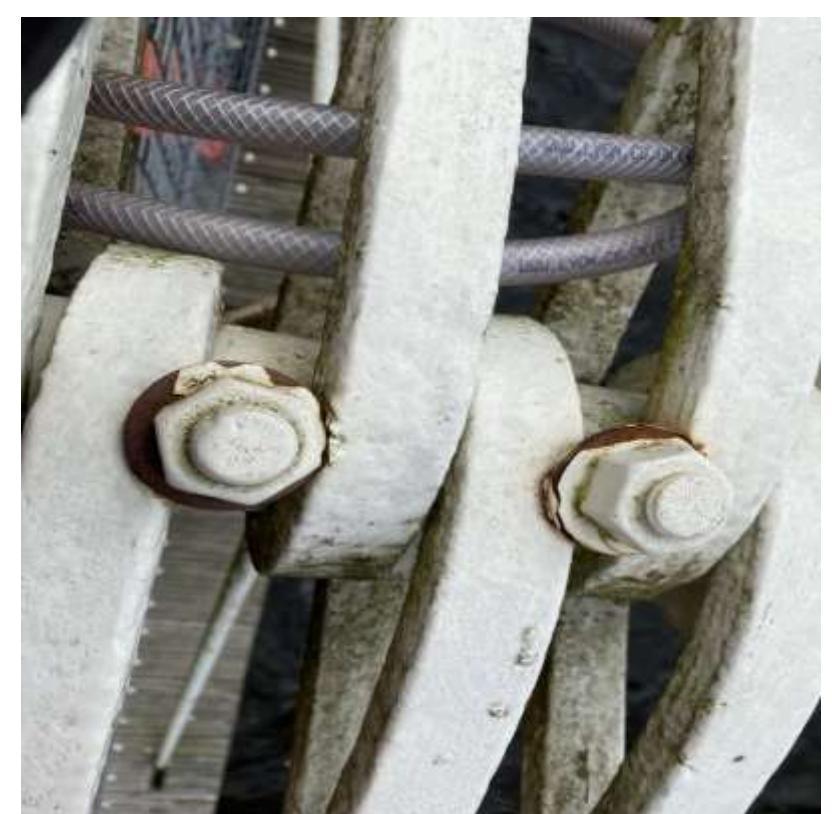
West chain link at 11m from pier missing top clamp plate, photo 33. Typical abraision of threads at interface with chain hanger due to dynamic movements are shown on photo 59.

Photo 33: Catenary chain hanger: West chain link at 11m from pier missing top clamp plate.

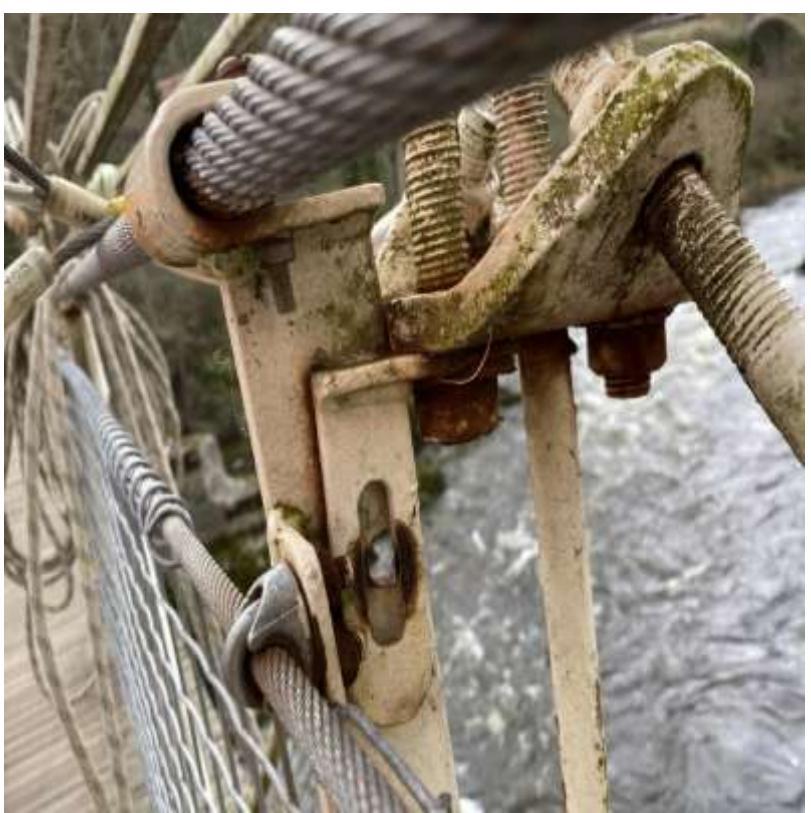
The parapets comprise welded mesh panels that are supported by tensioned wire rope members that are connected to vertical metallic posts. The vertical posts are connected to the timber decking, see photos 24, 32, 27 & 56. Missing fixing into parapet from tiebar links at 11m noted, photo 34.

Photo 34: West parapet: Missing fixing into parapet from tiebar links at 11m.

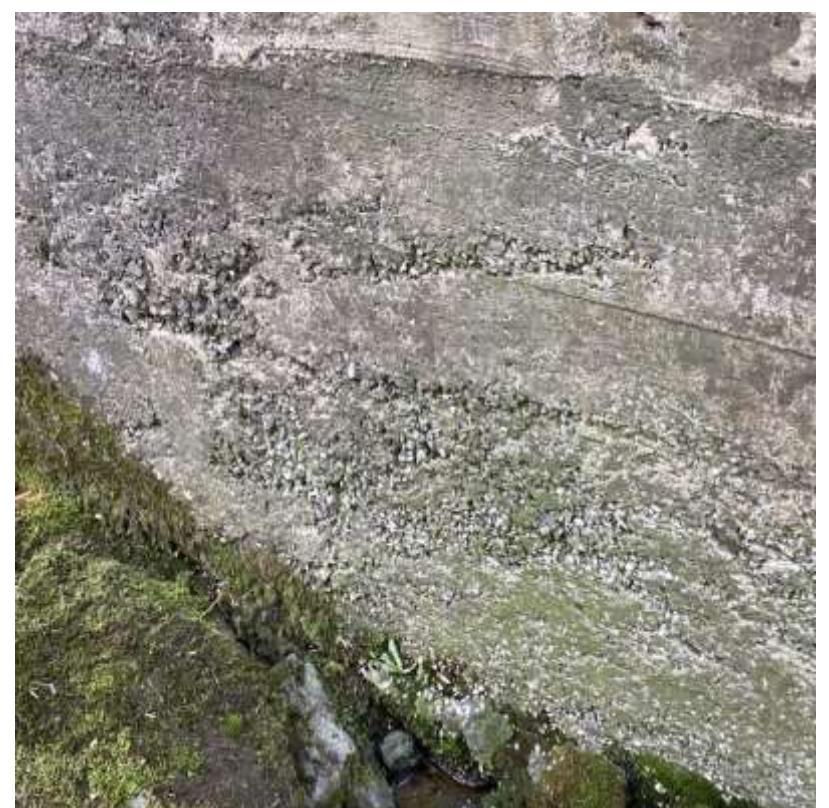
Photo 37: South face of pier. Typical example of poor concrete compaction to 20% of surface area.

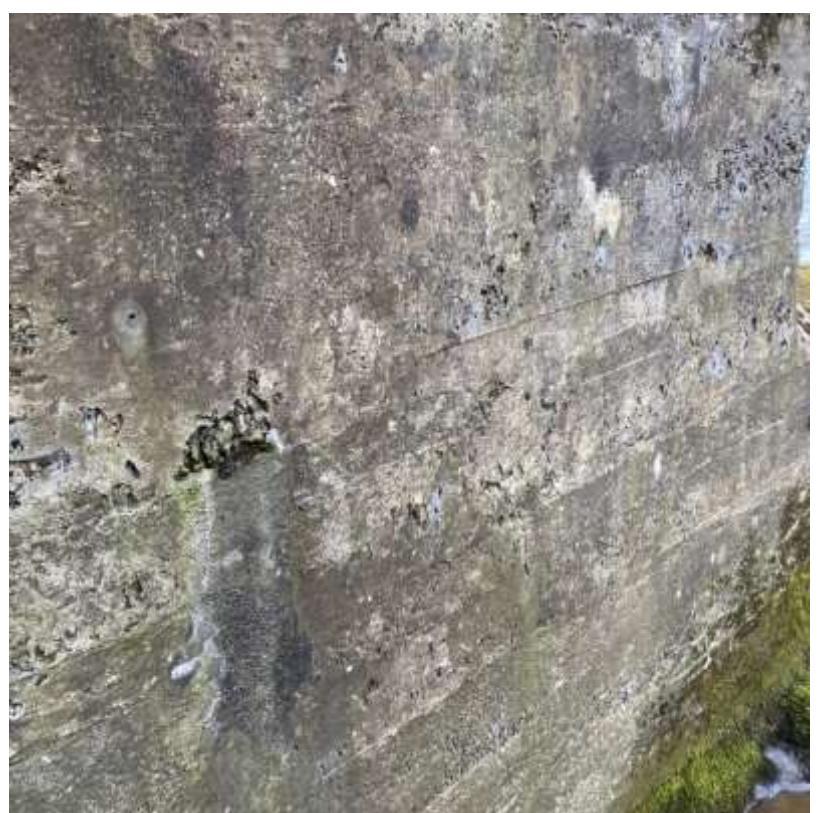
Photo 38: South face of pier. Typical example of poor concrete compaction to 20% of surface area.

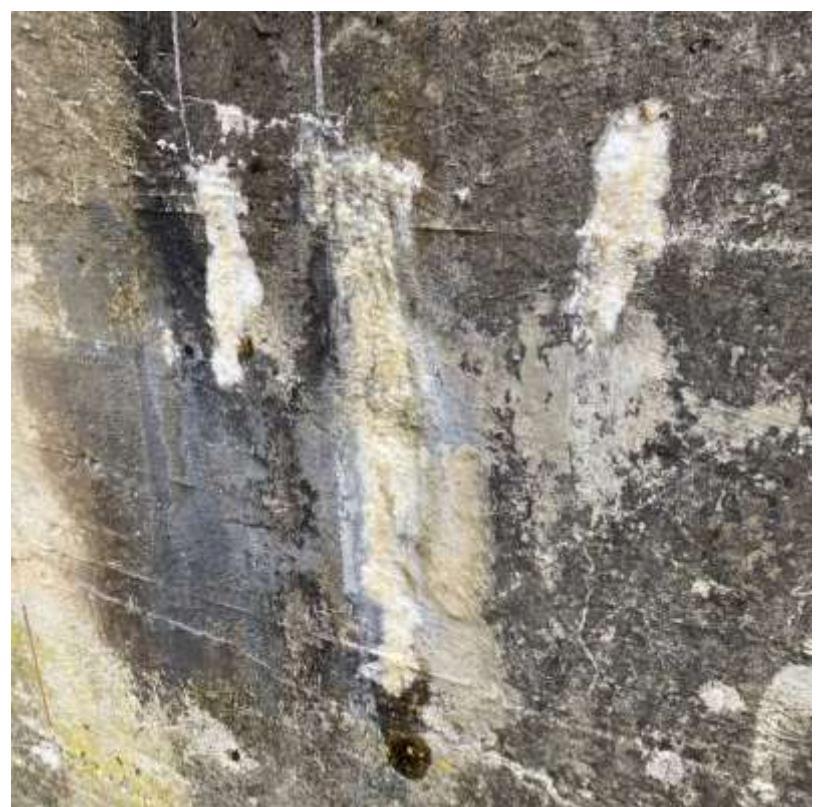
The concrete pier is in fair condition overall and exhibits areas of moss growth on the shoulders and at river level, see photos 7 and 40. A vertical band of efflorescence is present to the North elevation, see photos 7 and 39.

Photo 39: Calcite deposits to North face of pier 2.5m from west end and 1.5m up from ground level.

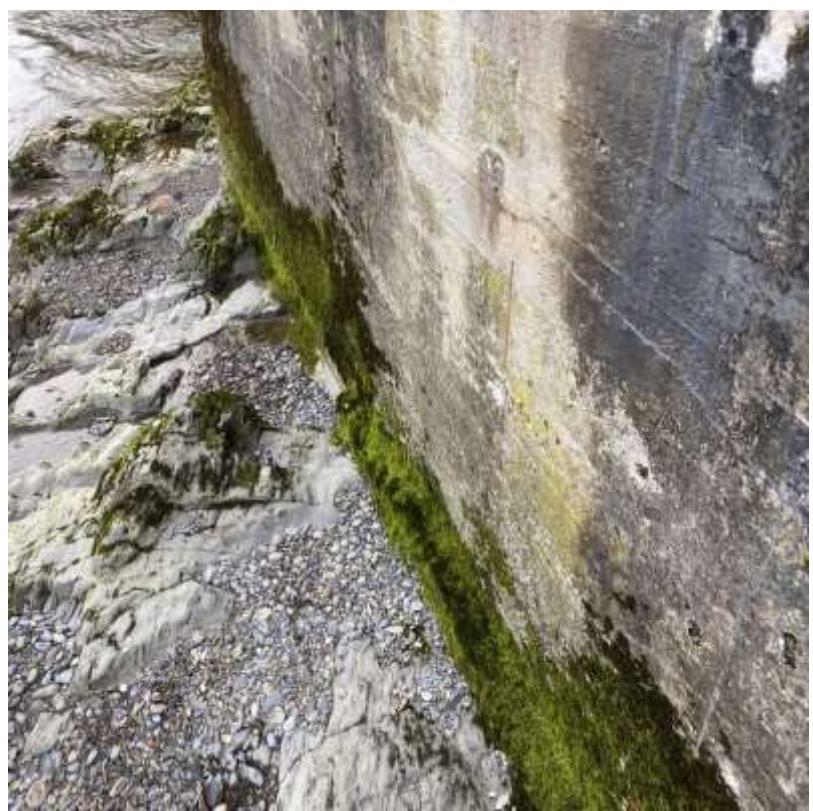
Photo 40: Moss growth to base of pier extending to a height of 600mm.

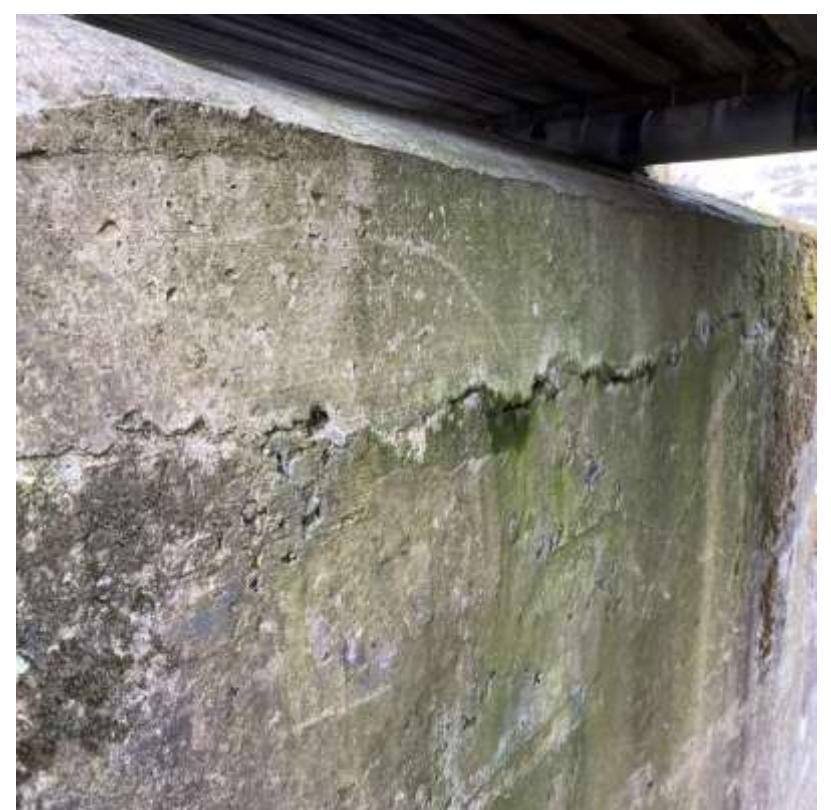
Photo 41: Horizontal cold joint to the top of the pier's South face, 1.5m long and up to 3mm wide.

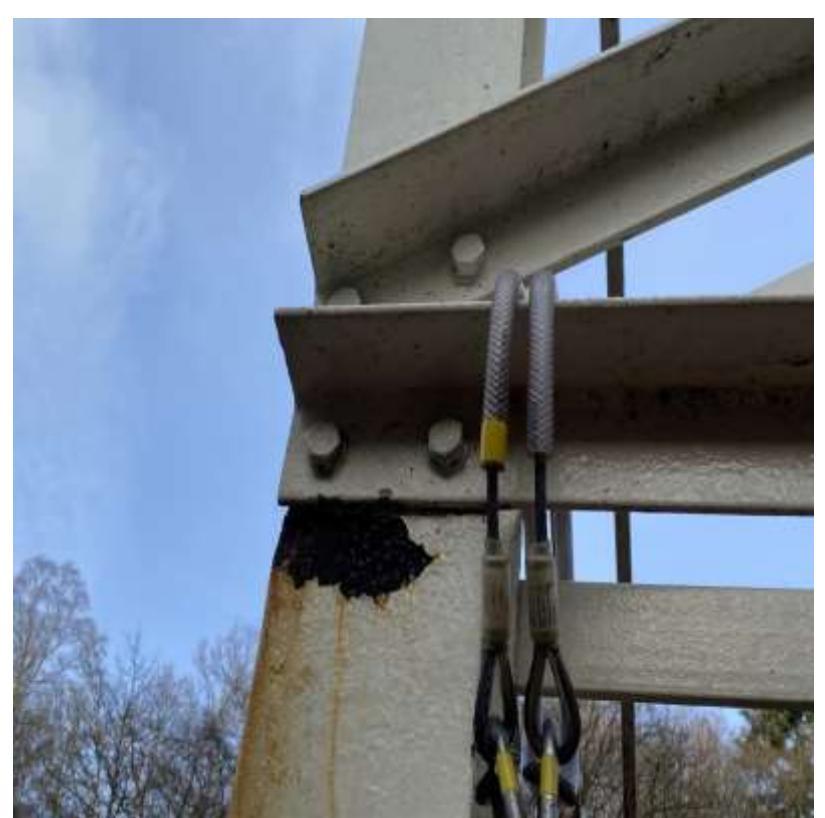
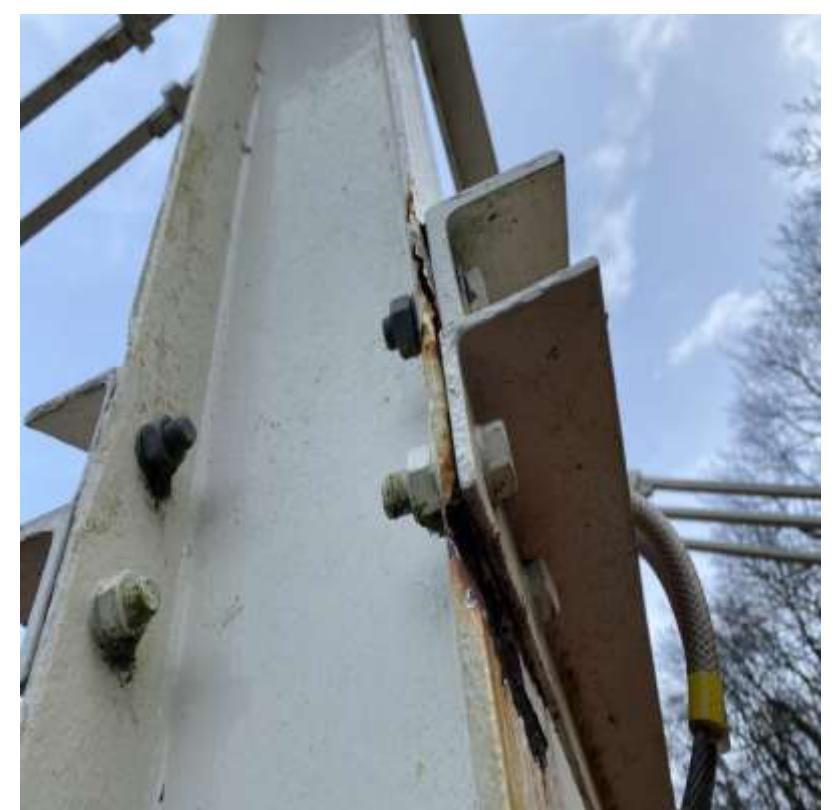
The South pylon is generally in fair condition with no major defects present. There is a small localised area (140mm \times 100mm) of corrosion present at the interface between the high level cross brace member and the pylon's West leg, see photos 42 and 43. It is estimated that at this location the remaining steel thickness has been reduced to 3mm.

Photo 42: South pylon West leg: 140x100mm area of corrosion and section loss (down to 3mm) at cross brace connection.

Photo 43: South pylon West leg: 140x100mm area of corrosion and section loss (down to 3mm) at cross brace connection.

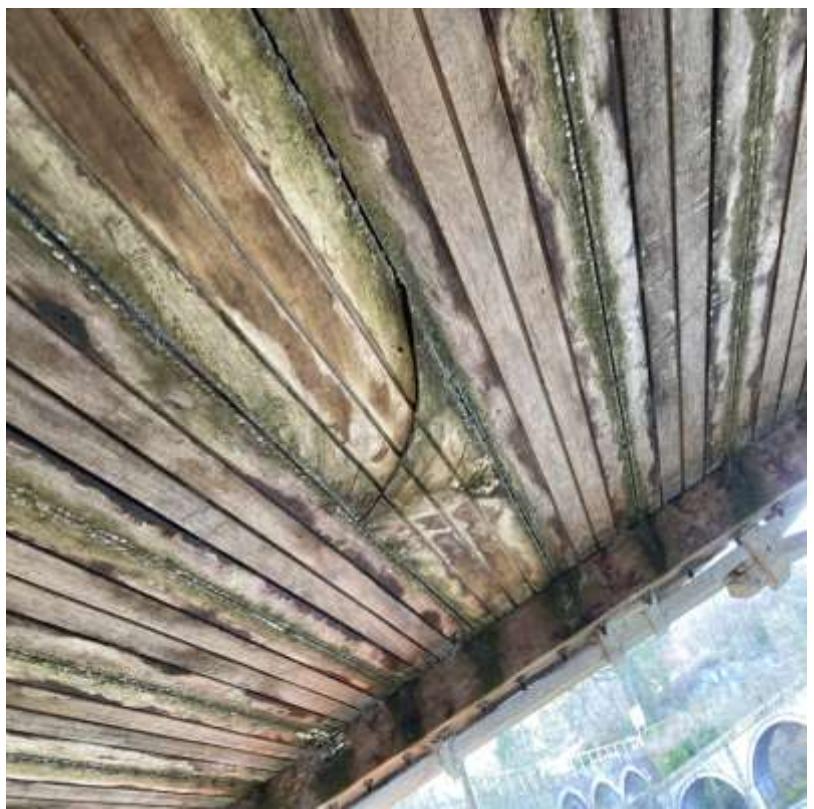
At Ch5.42m from the South abutment one timber deck plank has fractured, see photo 44.

Photo 44: Fractured timber deck board at Ch5.42m from South abutment.

- To mitigate health and safety risks associated with slips, trips and falls of footbridge users it is recommended to repair the defective timber decking planks identified in section 3.4 in the immediate/short term.

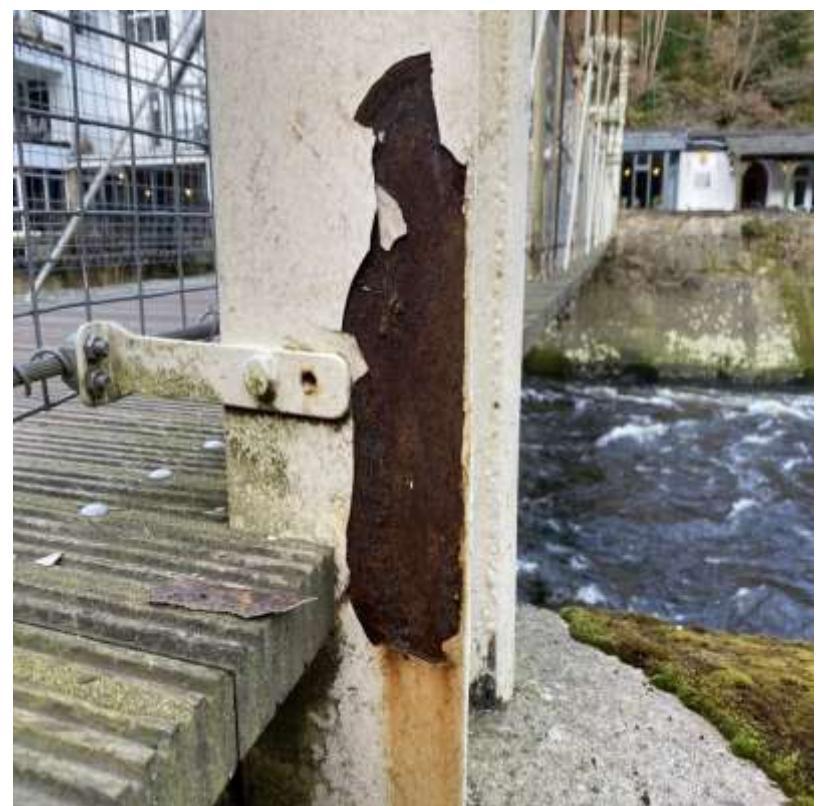
A small area (300mm x 90mm) of exposed steelwork is present to the East stanchion of the South pylon, this is caused by localised failure of the protective paintwork, see photo 47. At this location the steelwork has surface corrosion but no significant loss of section.

Photo 47: An area (300mm x 90mm) of paint loss and surface corrosion to the base of the South face of the East stanchion of the South pylon. 1no missing fixing to parapet bracket.

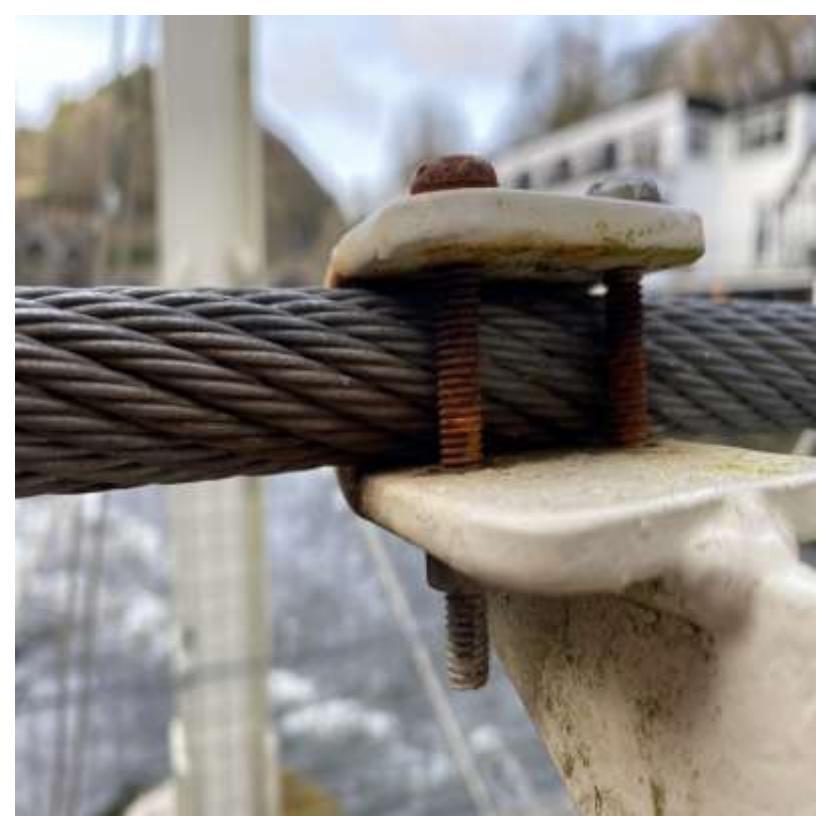
Photo 48: Parapet: Typical example of surface corrosion to top cable fixings.

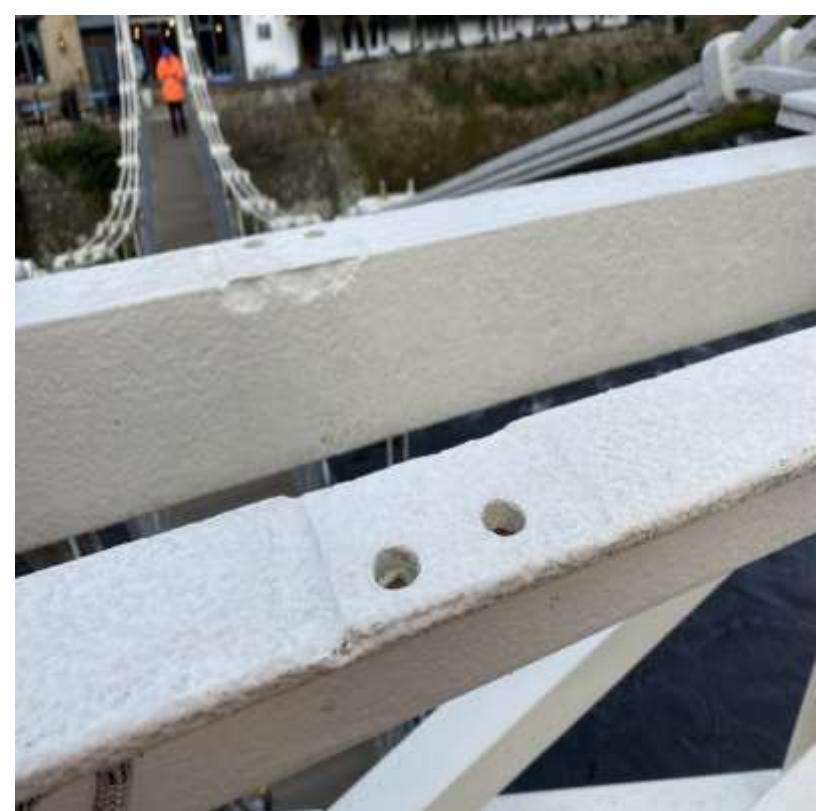
Photo 51: South pylon cross member: Historic fixing with localised section loss to profile.

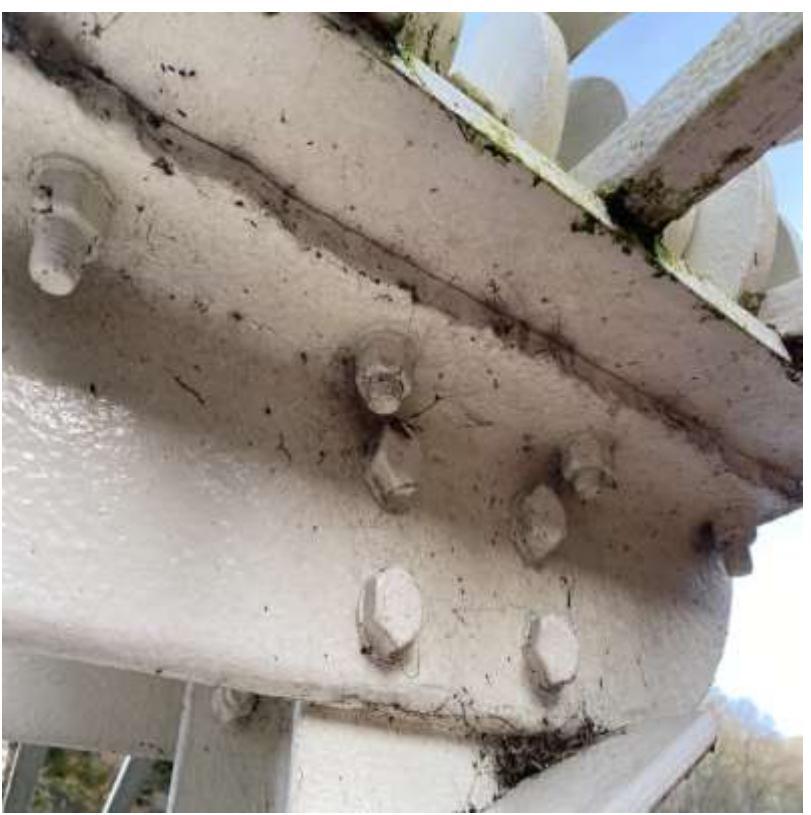
Photo 52: South pylon: Historic section loss to angle.

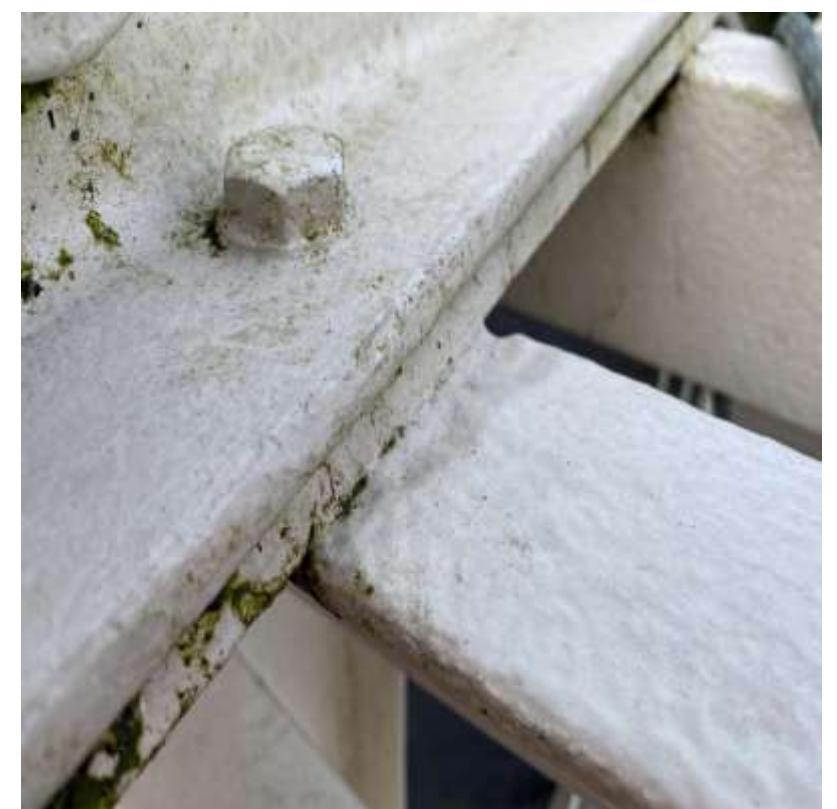
Photo 53: South pylon: Typical loss of section to cross member interface at top. (20mm wide by 3mm deep)

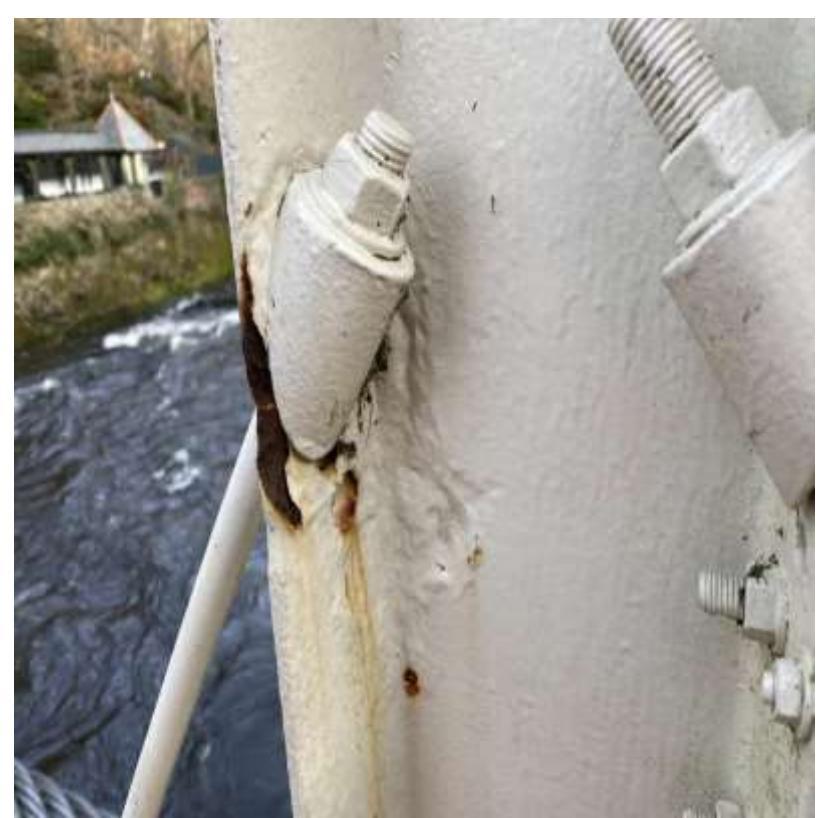
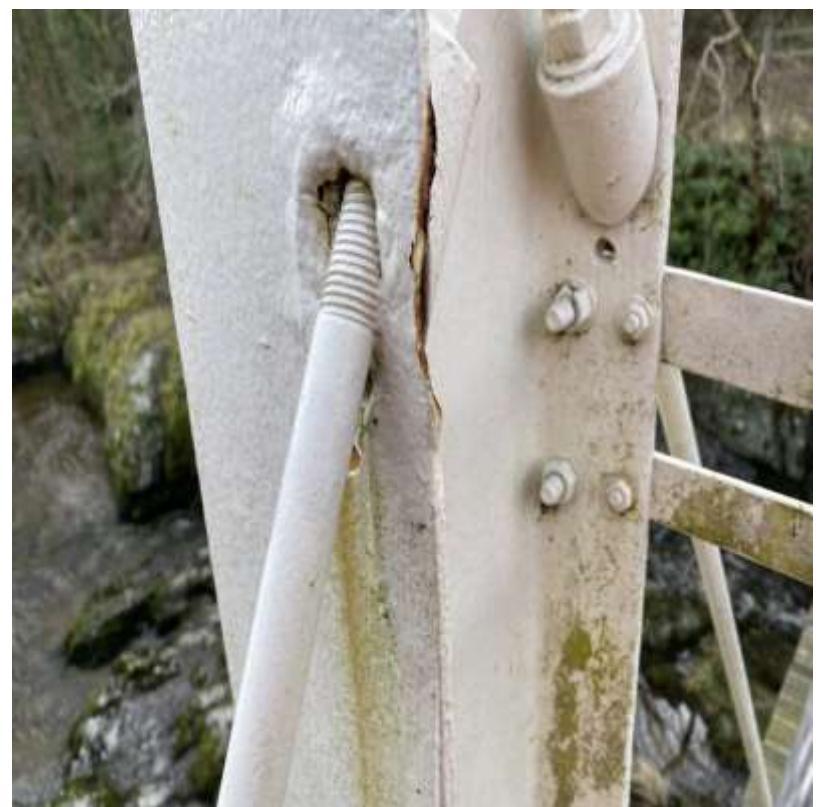
Localised section loss has been noted to the flange of the South pylon West stanchion, this has occurred at the hanger interface, see photos 54 and 55. At this location the remaining flange thickness is 7mm. Minor historic section losses noted to South pylon, photos 51 to 53.

Photo 54: South pylon: Section loss to flange of West stanchion at hanger interface. 120mm x 120mm area down to a thickness of 7mm.

Photo 55: South pylon: Section loss to flange of West stanchion at hanger interface. 120mm x 120mm area down to a thickness of 7mm.
