Asset Management Committee

Agenda 25.07.2022

Structure Name: Llangollen Chainbridge

Report Ref: R1052-01 Issue No 01

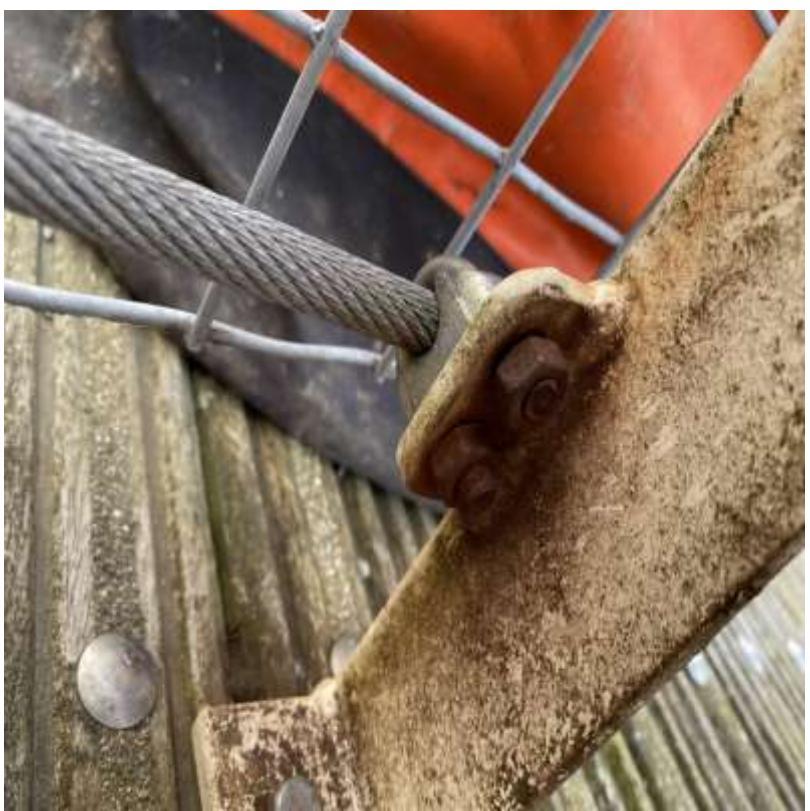
Photo 56: Parapet bottom cable fixings. Surface corrosion present throughout.

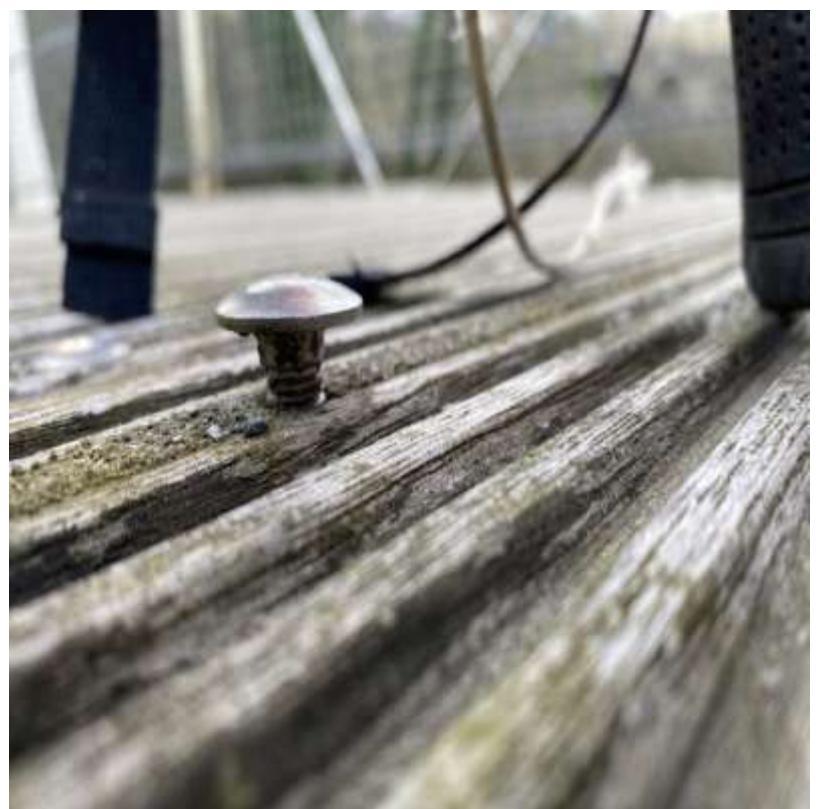
Protruding fixing noted to East edge at Ch7m, photo 57.

Photo 57: Deck boards: Protruding fixing to East edge at Ch7m.

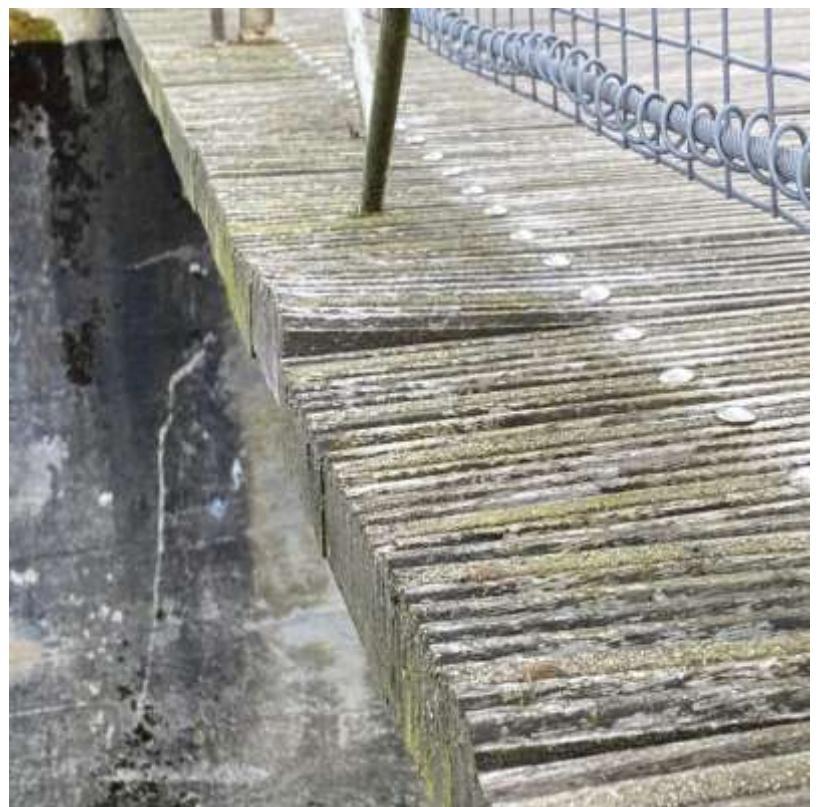
The timber decking is in fair condition overall. There are several deck boards that have undergone vertical displacement of up to 25mm, see photos 58, 72, 73 and 74. Furthermore, a small section (120mm x 150mm) of the timber decking appears to have been cut to the West side of the footbridge at 6.2m from the South abutment, see photo 71.

Photo 58: Vertical deflection of one deck board (25mm) to East edge at Ch5.6m.

- To mitigate health and safety risks associated with slips, trips and falls of footbridge users it is recommended to repair the defective timber decking planks identified in section 3.4 in the immediate/short term.

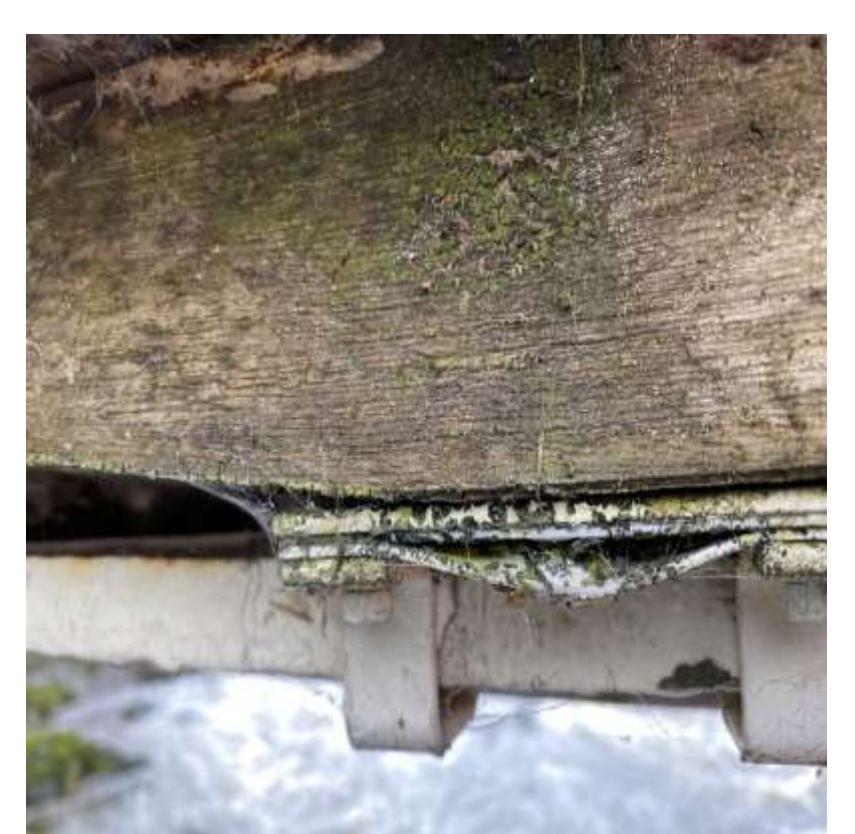
The deck chains are in good to fair condition overall only exhibiting localised areas of minor surface corrosion where the protective paint system has failed, see photo 17. The main defect noted to the deck chain is the deflection of the East chain at Ch14m, see photos 64 and 65, where the deck chain has deflected circa 40mm vertically. One of the East deck plates has deformed vertically by 12mm, photo 60.

Photo 60: Vertical deformation of the East deck chain plate (12mm) at CH9.9m.

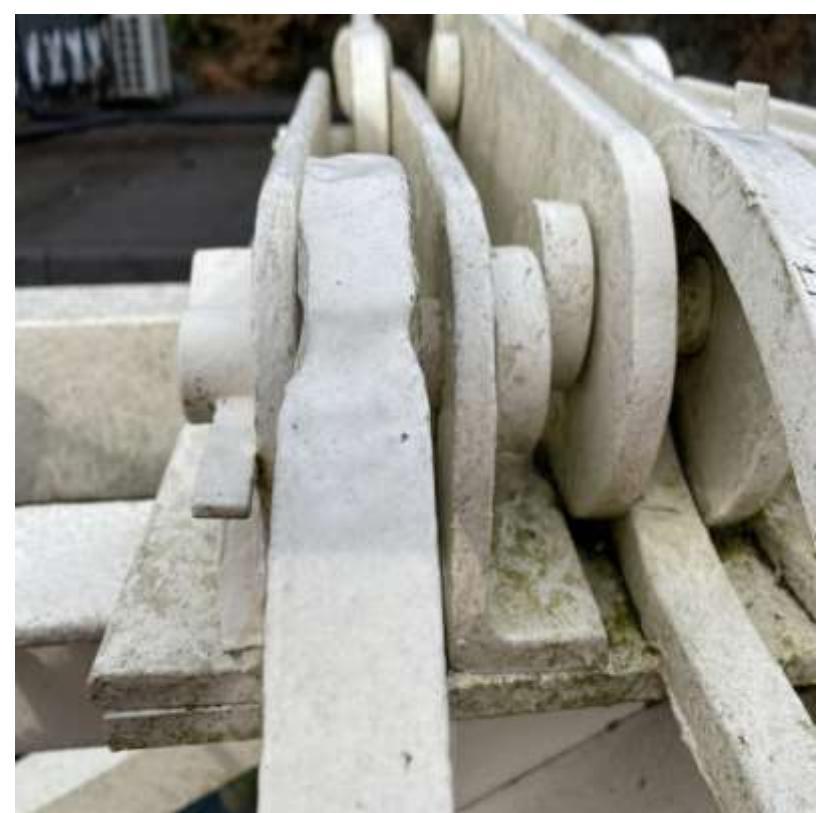
Historic thinning/necking of the East catenary chain over the North pylon has been noted, see photo 66, 10mm loss to 90mm wide section.

Photo 66: Thinning/necking of East catenary chain over North pylon. 10mm section loss to 90mm wide section.

- The cause of the necking/thinning observed to the East catenary chain over the North pylon is unknown and this could have been the result of corrosion or overstress, because of the significant section loss it is recommended that an assessment of the load carrying capacity of the catenary chain is conducted, the output from which should inform on planning future monitoring regime for this element.

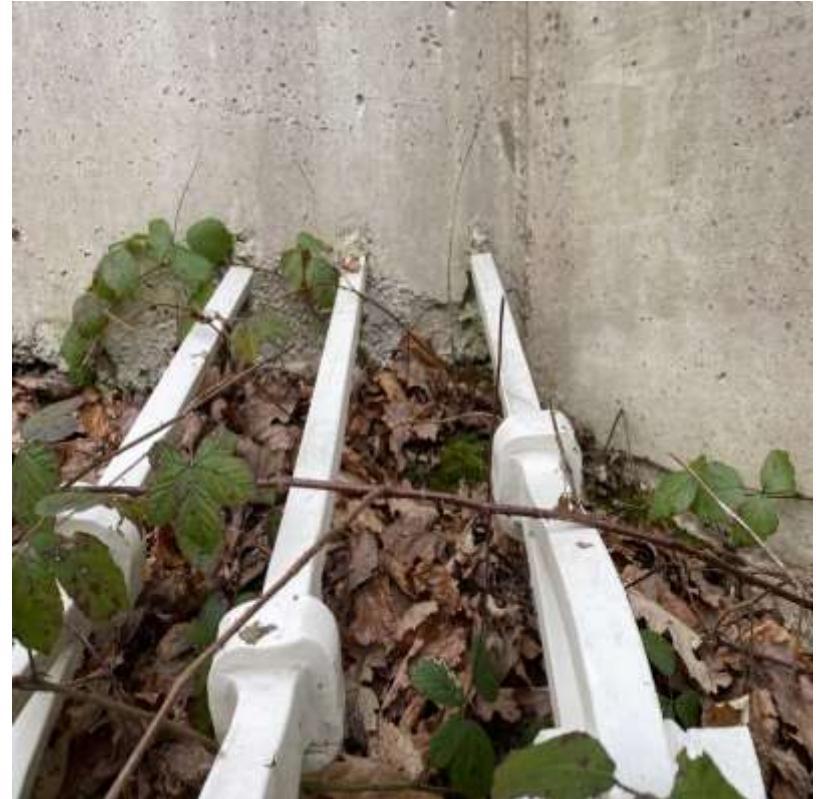
The Northern chain anchor block is located at high level and part way up an embankment. The anchor block is of concrete construction and is generally in good condition overall with only localised areas of spalling present at the interface between the concrete and chains, see photos 35, 68 and 69.

Photo 69: Spalled concrete around Northeast catenary chain anchor.

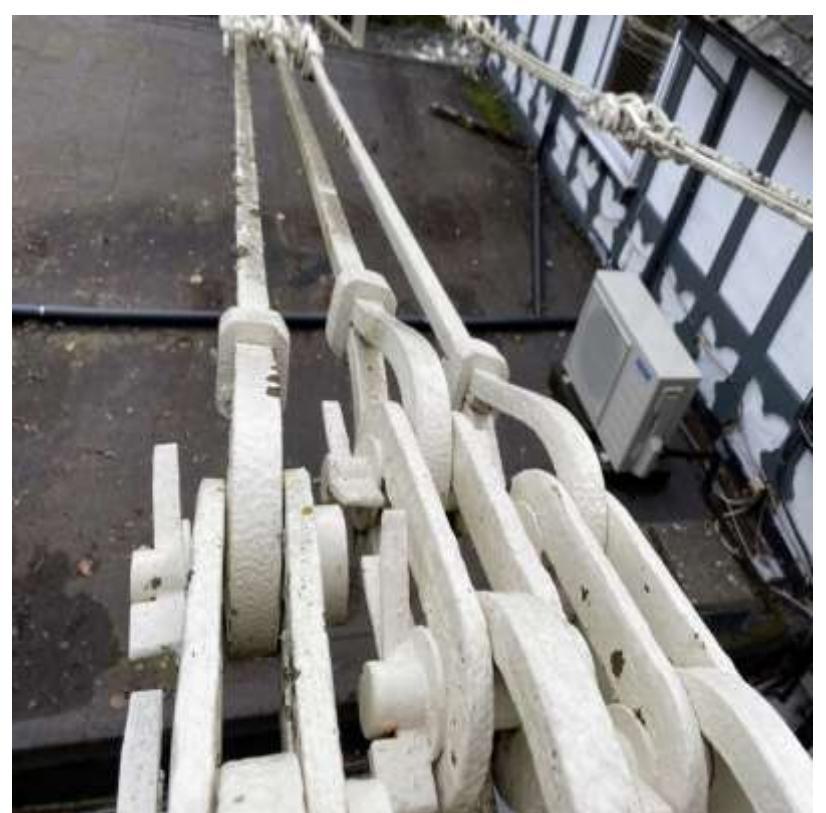
The chains have recently been refurbished and the condition of the protective paintwork present is generally good with only localised areas of paint failure, photo 32. Typical pitting /localised corrosion spots (to 1mm) noted, photo 70.

Photo 70: Catenary chain - North backspan: Typical pitting to links to North block. 1mm typical pitting depth and minor localised corrosion spots.

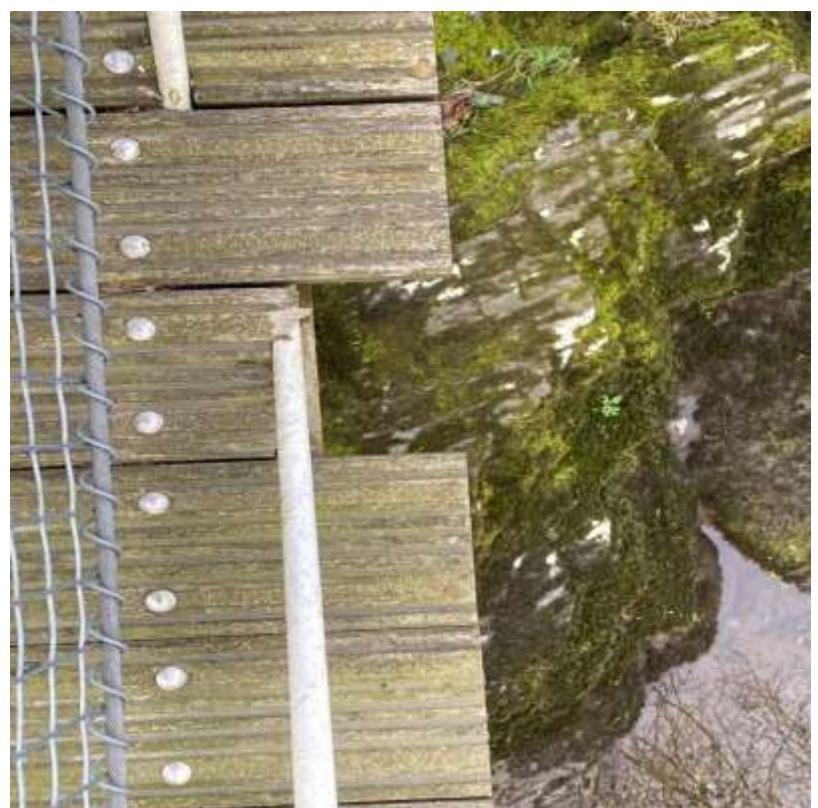
Photo 71: 120mm x 150mm section of timber decking missing on the West side at 6.2m from the South abutment.

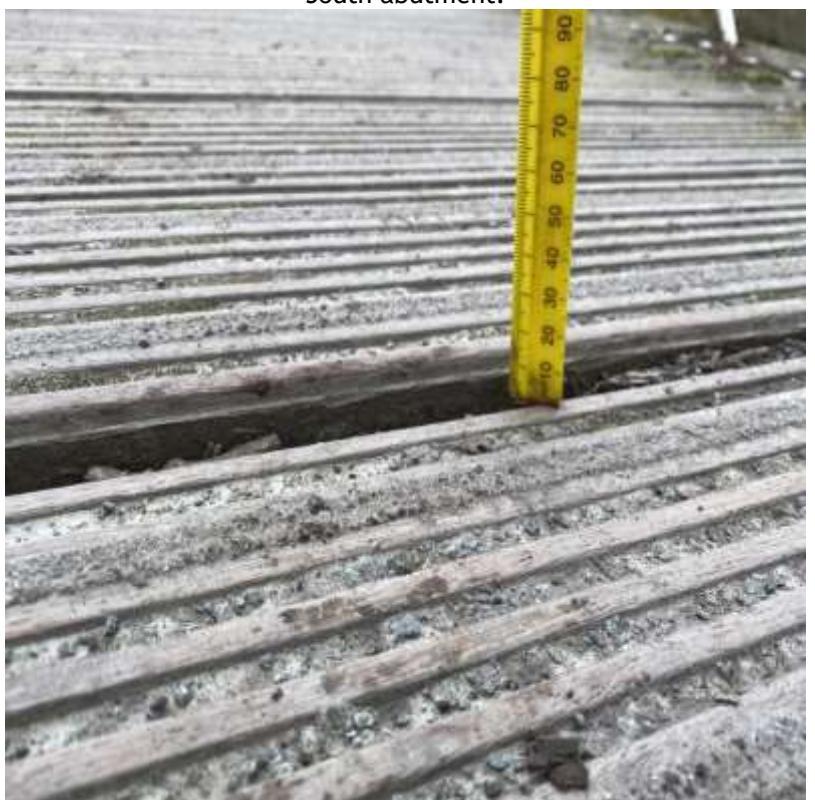
The timber decking is generally in fair condition. Three planks were noted as being vertically displaced above the general decking level by up to 10mm, these planks are at 3.2m, 5.4m and 7.5m from the South abutment, see photos 72, 73 and 74.

Photo 72: 5mm vertically displaced timber deck plank at 3.2m from South abutment.

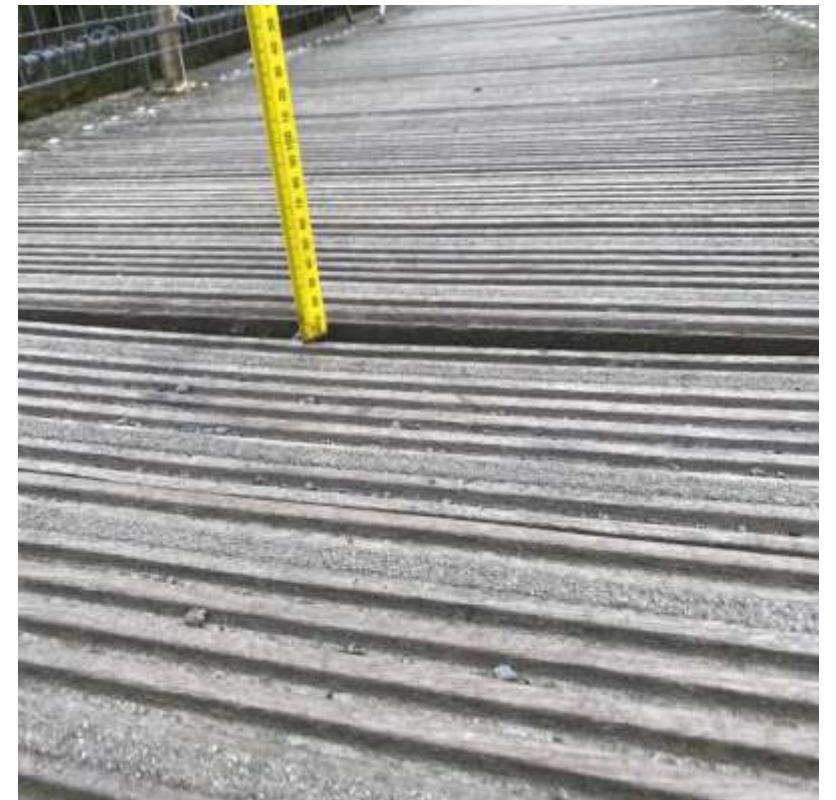
Photo 73: 10mm vertically displaced timber deck plank at 5.4m from South abutment.

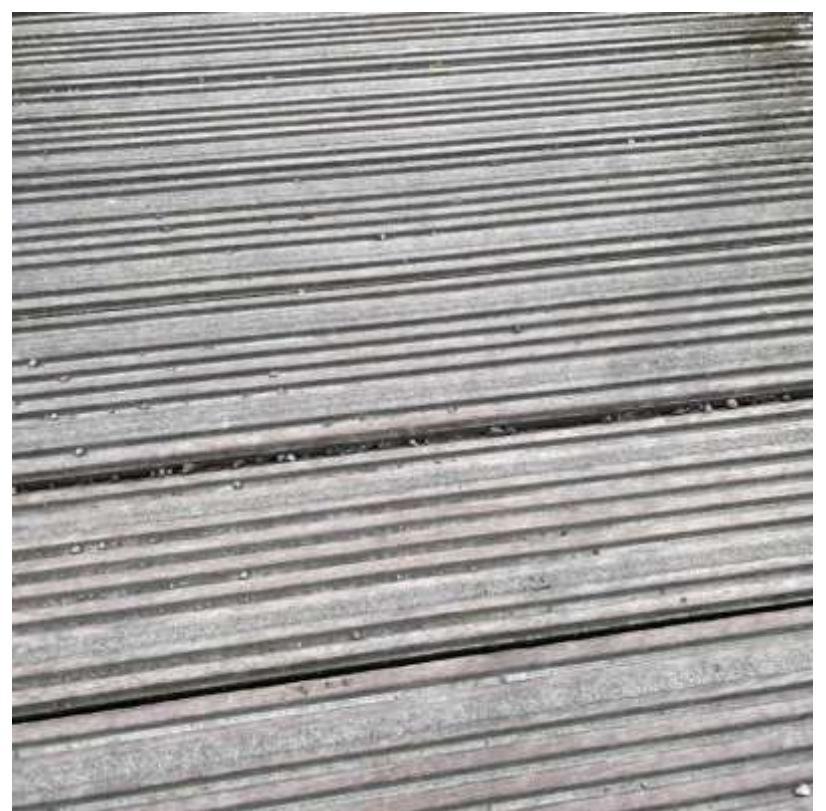
Photo 74: 10mm vertically displaced timber deck plank at 7.5m from South abutment.

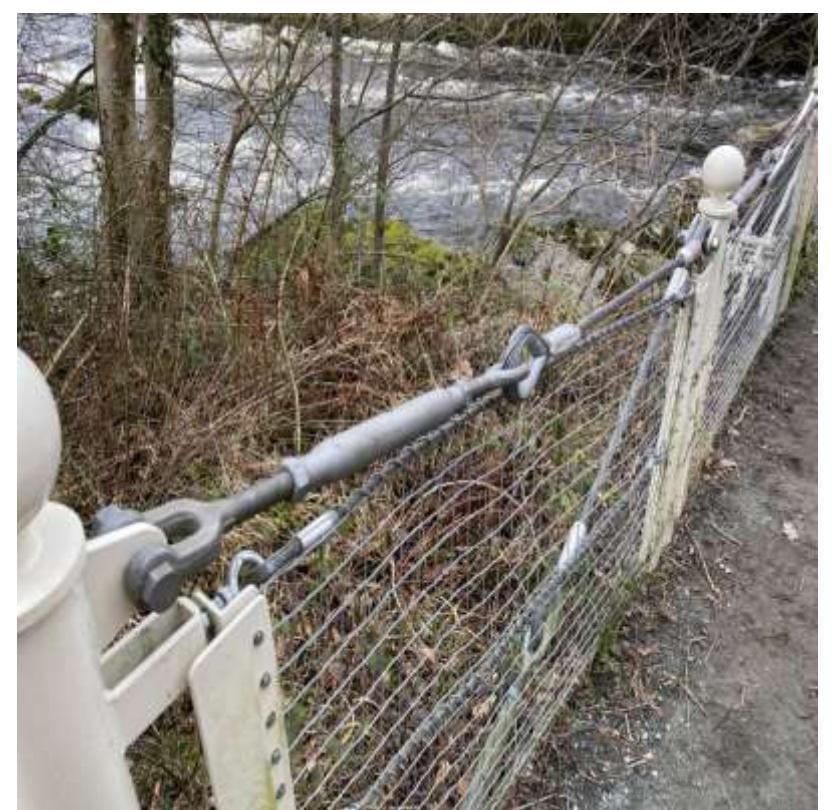
The tensioning cables to Southwest and Southeast parapet are loose and require tightening, see photo 75.

Photo 75: Both the Southwest and Southeast parapet tensioning cables are loose over a 910mm length.
