Asset Management Committee

Agenda 25.07.2022

Structure Name: Llangollen Chainbridge

Report Ref: R1052-01 Issue No 01

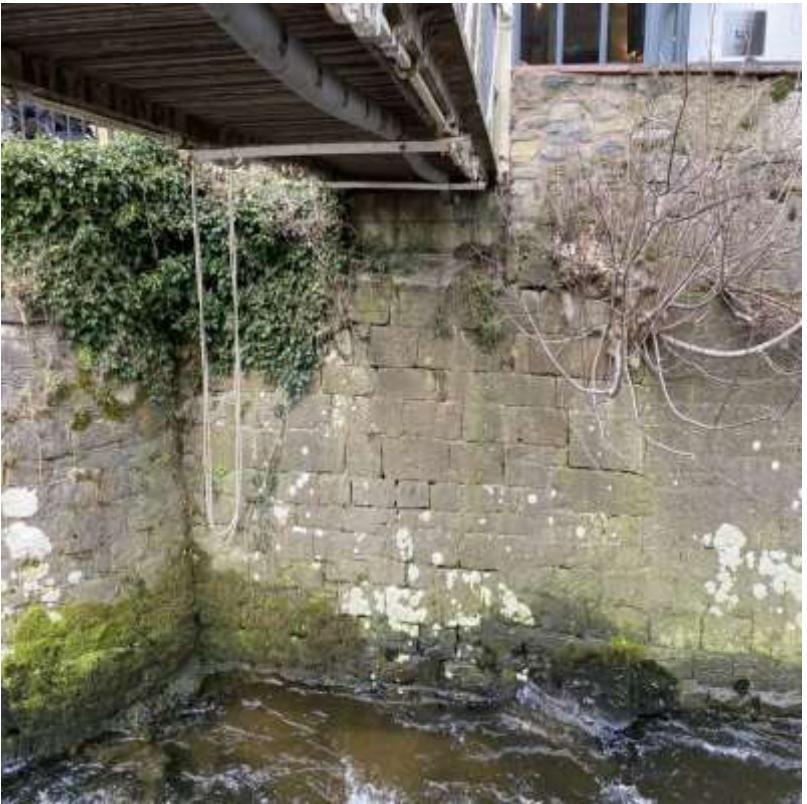
The North abutment is in fair condition exhibiting extensive moss growth at the river interface and missing joint mortar that extends the full height of the abutment face, see photo 6. Ivy growth is present to the West side of the footbridge at the upper level of the North abutment, see photo 20. An established tree growth is present at the upper level of the North abutment to the East side of the footbridge, see photos 6 and 19.

Photo 6: General view on North abutment.

- Repoint North abutment (photo 6) where bed joint mortar is missing.
- Consider adding guardrails around catenary chain anchor block at North embankment (photo 15)

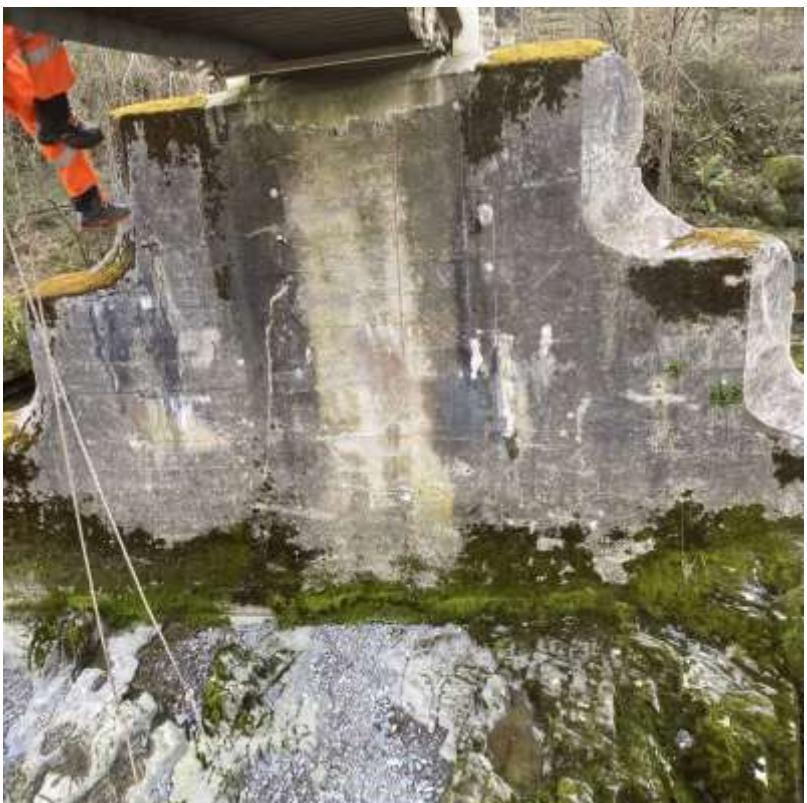
The concrete pier is in fair condition overall and exhibits areas of moss growth on the shoulders and at river level, see photos 7 and 40. A vertical band of efflorescence is present to the North elevation, see photos 7 and 39.

Photo 7: General view looking South towards North face of pier.

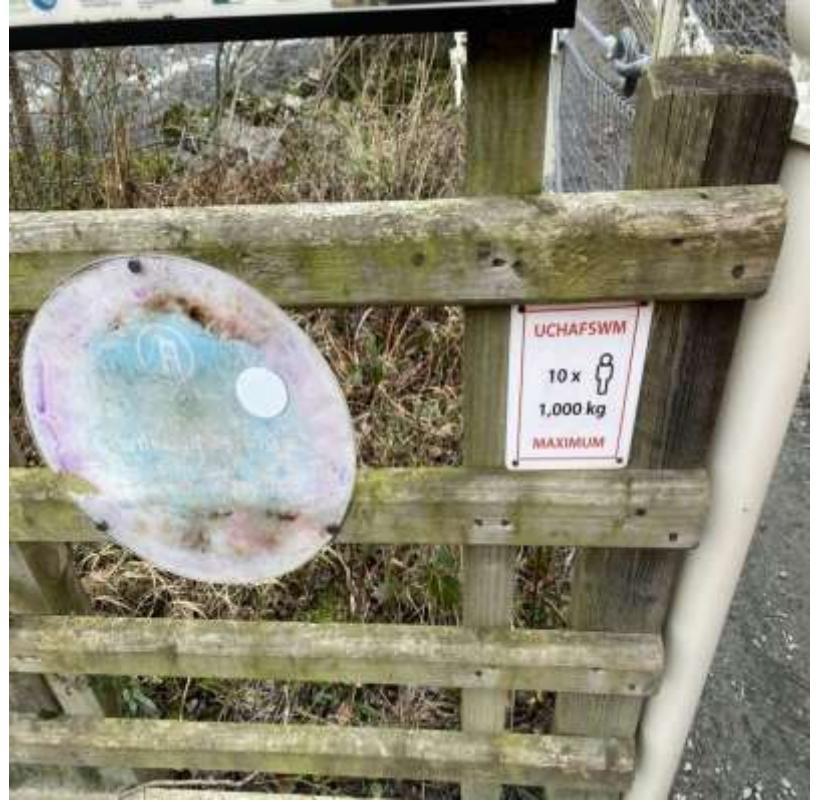
General pedestrian signage is present to the South approach, see photos 12 and 13. The condition of the signage is generally good however, one sign is illegible (circular sign in photo 13). The weight limit sign for the structure, 1000kg (or 10 people), is clear and legible.

Photo 13: General Signage at South approach.

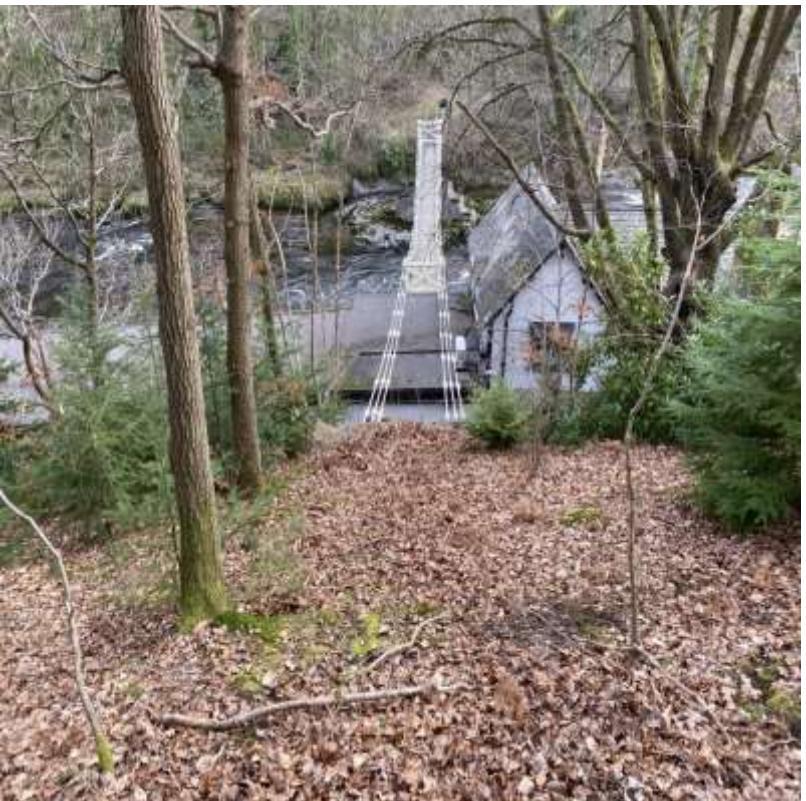
There is no safety fencing or guardrailing surrounding the Northern chain anchor block, see photo 15.

The North embankment is heavily vegetated with mature tree growths present, see photo 15.

Photo 15: North embankment. No safety fence or guardrails around chain anchor block.

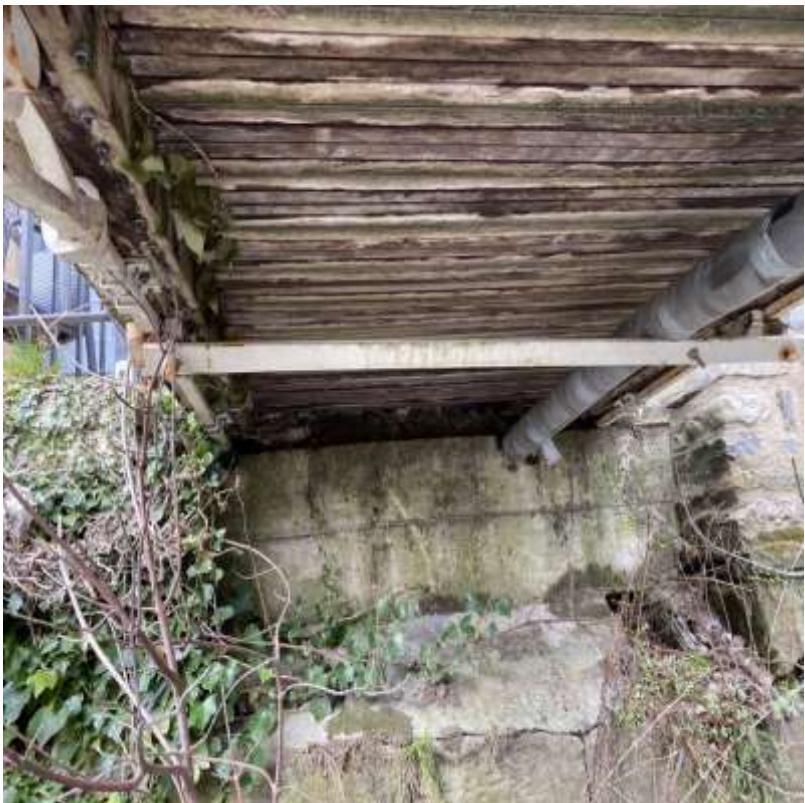
Under deck bracing members are present between the East and West deck chains, see photo 10, 11 17 & 20. The bracing members are at regular longitudinal centres. The overall condition of the under-deck bracing members is fair and the principal defects present to these members include light surface corrosion at localised areas where the protective paint has failed, see photo 17, 20 & 64.

Photo 20: North abutment - Ivy growth to Northwest.

- Remove vegetation present at high level to the North abutment (photos 19 & 20).
- Refix all loose parapet upstand fixings (photos 24 & 27).
- Replace 4No. soft timber decking boards present at South end of South span (photo 67).

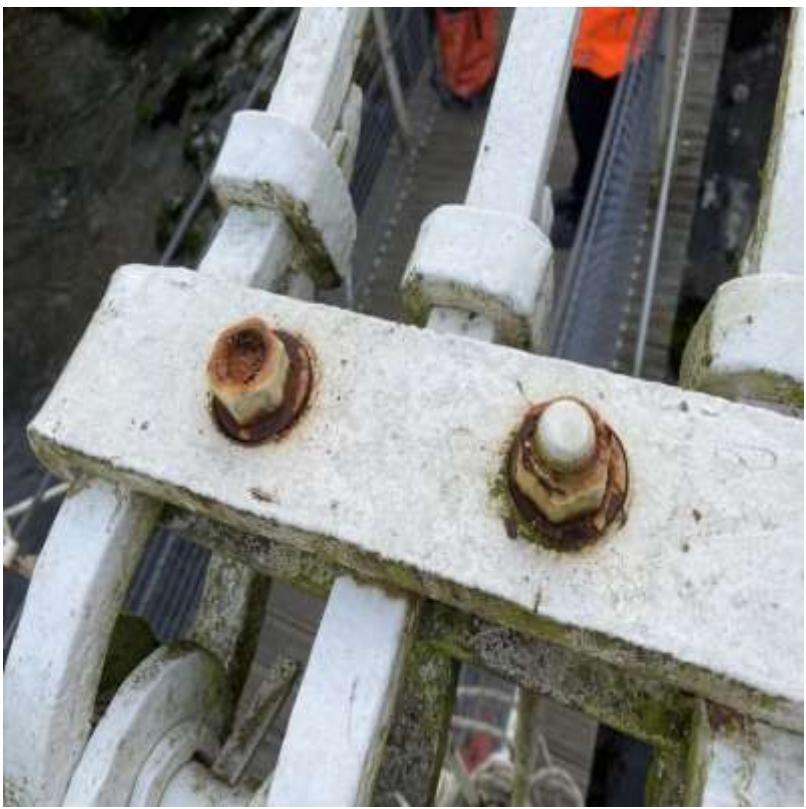
Photo 30 Catenary chain hangers: 4.08m South of pier, insufficient thread protrusion to 1no vertical hanger anchor.

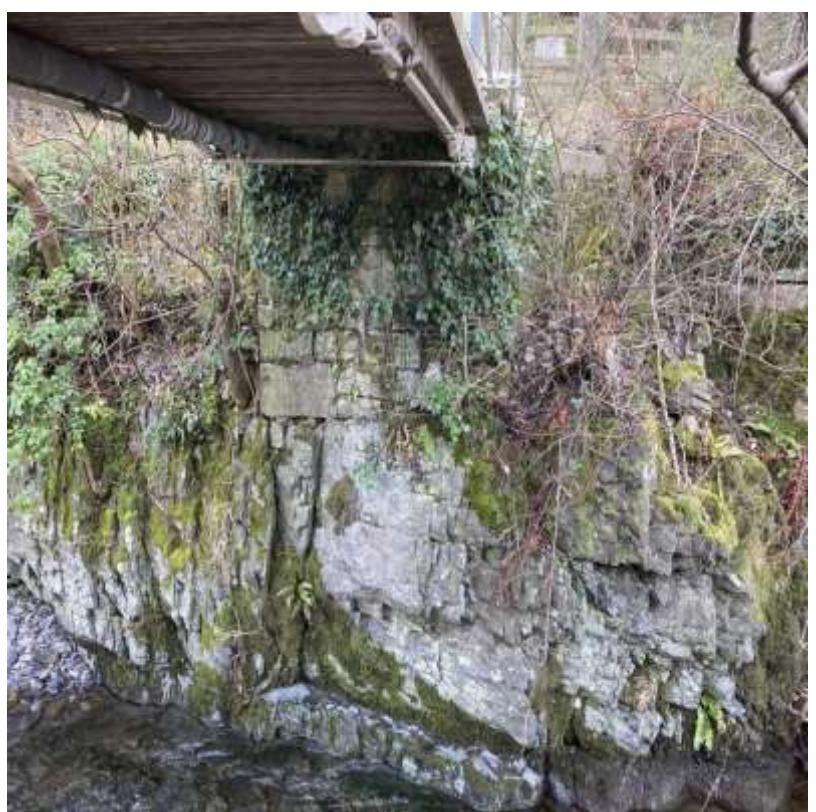
The south abutment comprises natural rock face up to half way up and masonry blockwork laid in courses above, see photo 36. Large area of moss growth is present to the lower portion of the abutment and ivy growth to the upper portion, see photos 36 and 46.

Photo 36: South abutment.

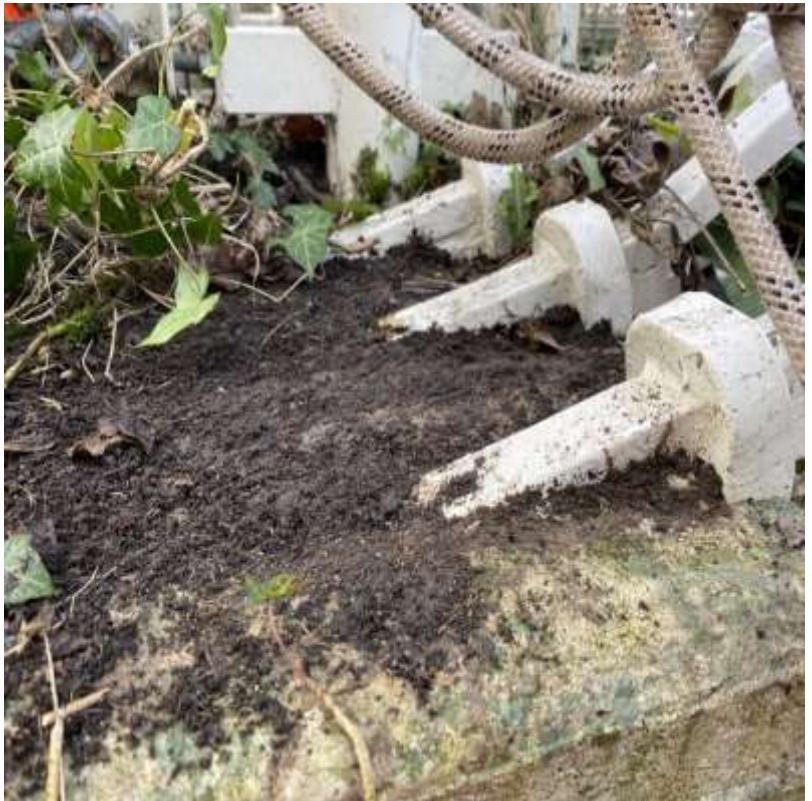
Photo 45: East catenary chain South anchor detail.

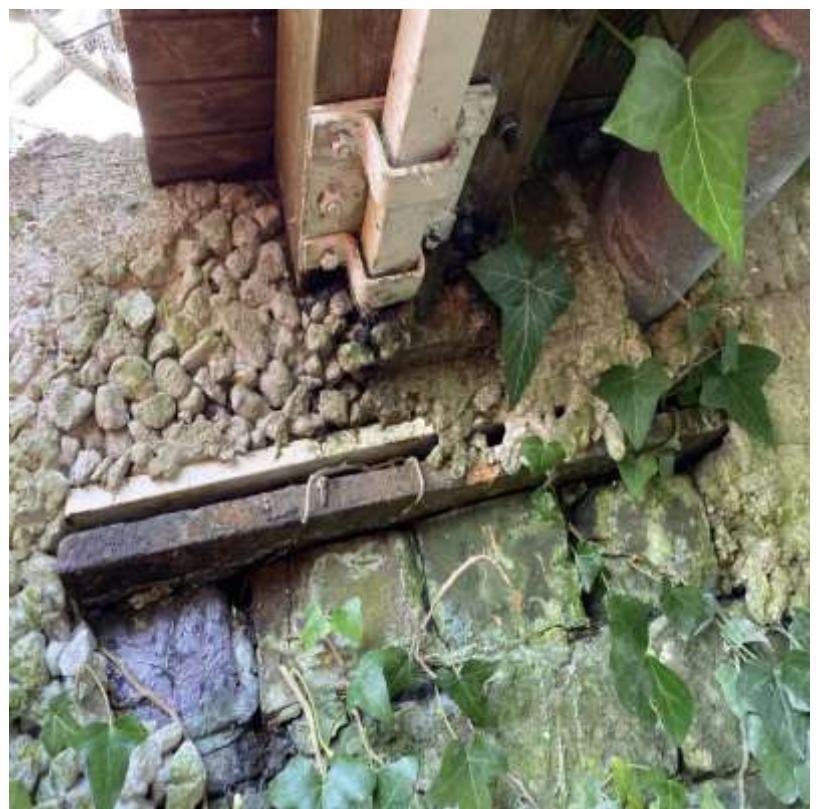
The deck chains appear to be anchored into the same anchor block to the south and separate anchor block to the north. The south anchor block appears to be made of poorly compacted concrete, photos 46, 49.

Photo 46: South abutment: East deck chain anchor.

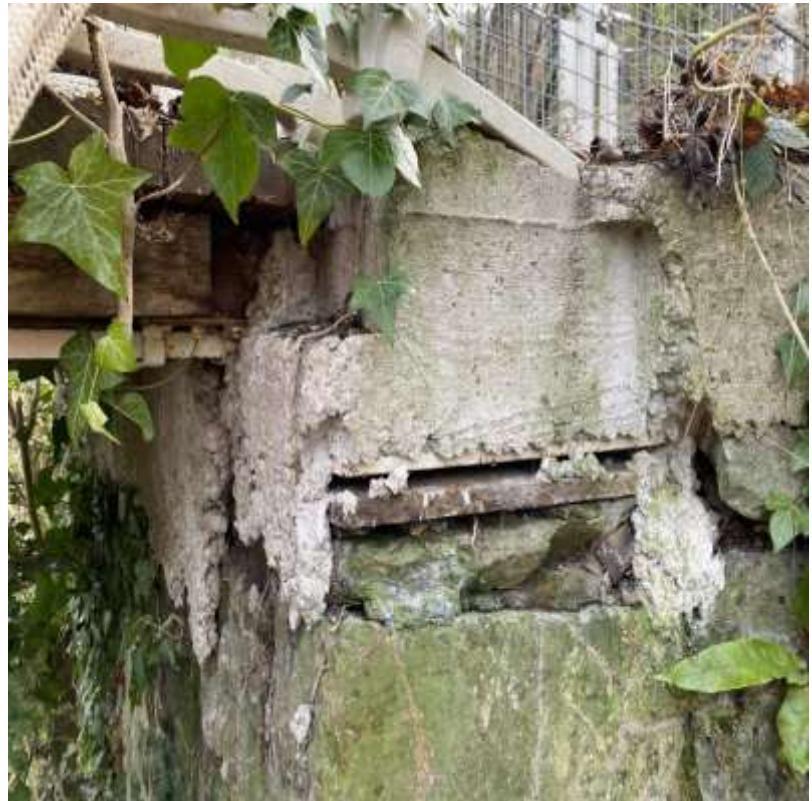
Photo 49: South abutment: West deck chain anchor details.

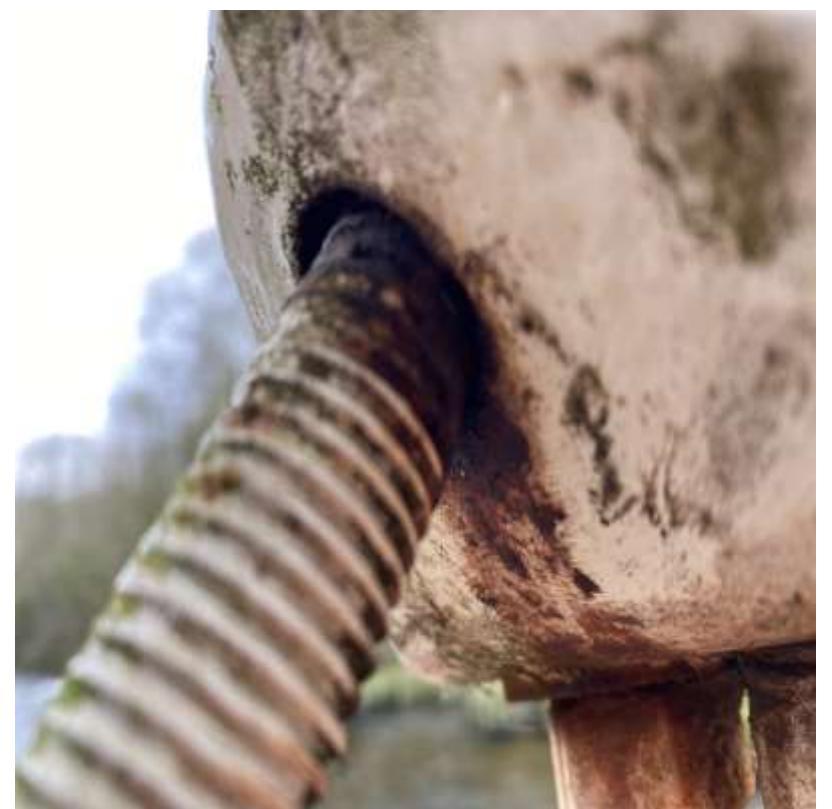
Photo 59: Catenergy chain hanger.

- Monitor or replace distorted timber plank (photo 58)
- Monitor abrasion and corrosion loss to all existing connections and replace or repair where deemed necessary (photo 59)

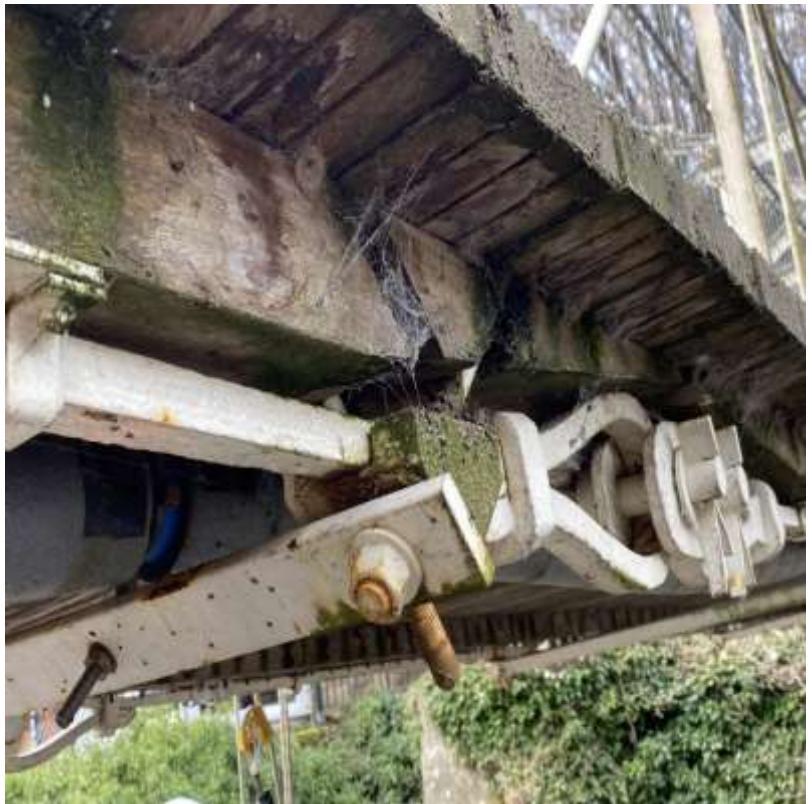
Photo 64: 40mm vertical deflection of East deck chain at Ch14m.

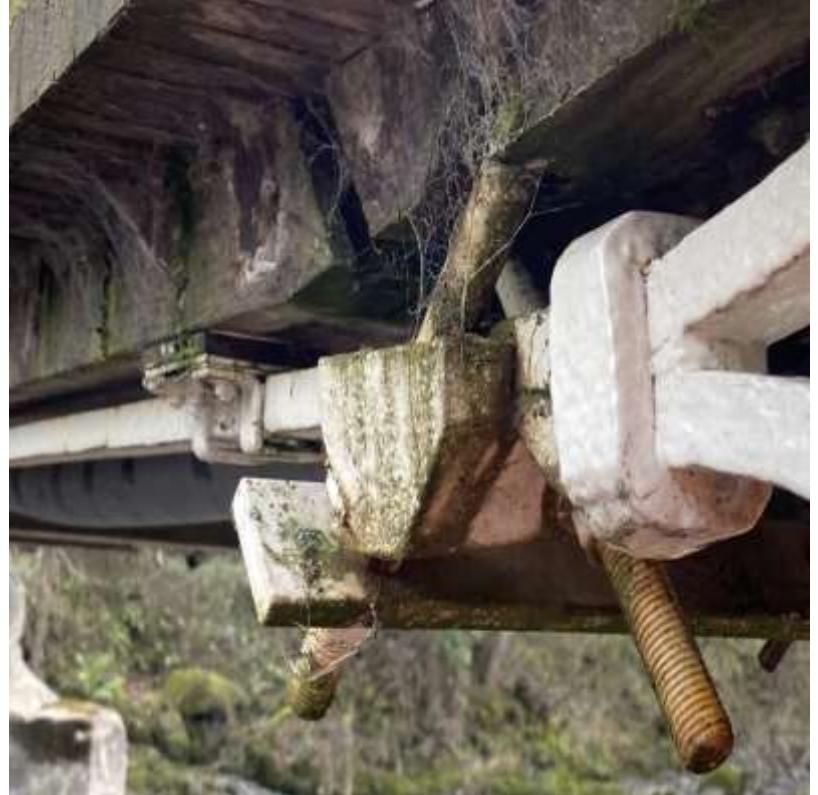
Photo 65: 40mm vertical deflection of East deck chain at CH14m.

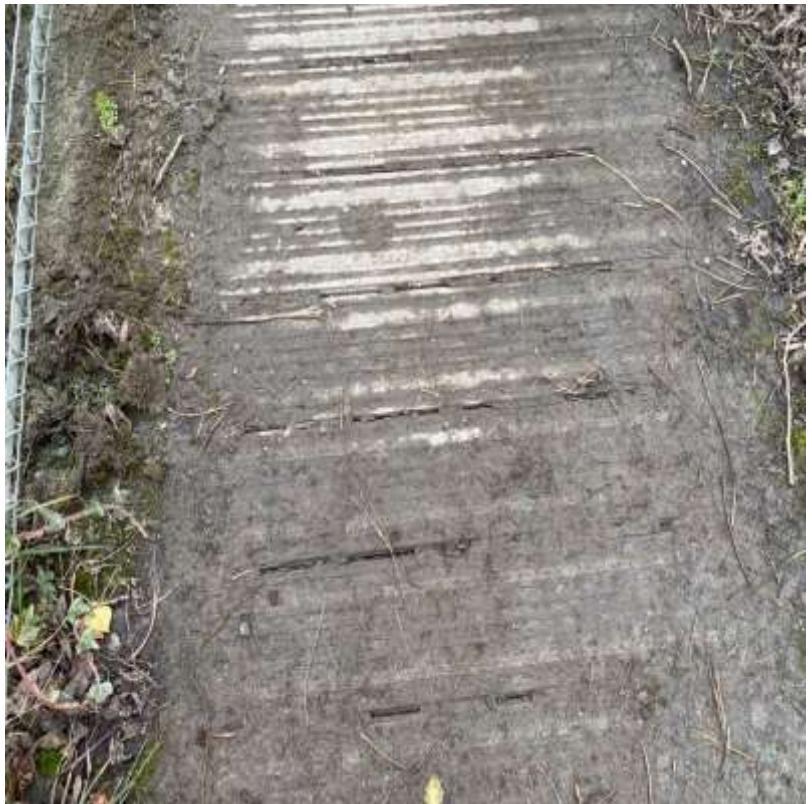
4no timber boards noted to be soft at South end of South span, photo 67.

Photo 67: 4No timber boards soft at South end of South span.
